June 25, 2018  
File No. 5171-06-01

RE: May 2018 PCB BMP Quarterly Status Report  
Burncoat High School

Table 1 - Summary of BMP Observations  
 Burncoat High School  
 179 Burncoat Street  
 Worcester, MA 01606  
 May 24, 2018

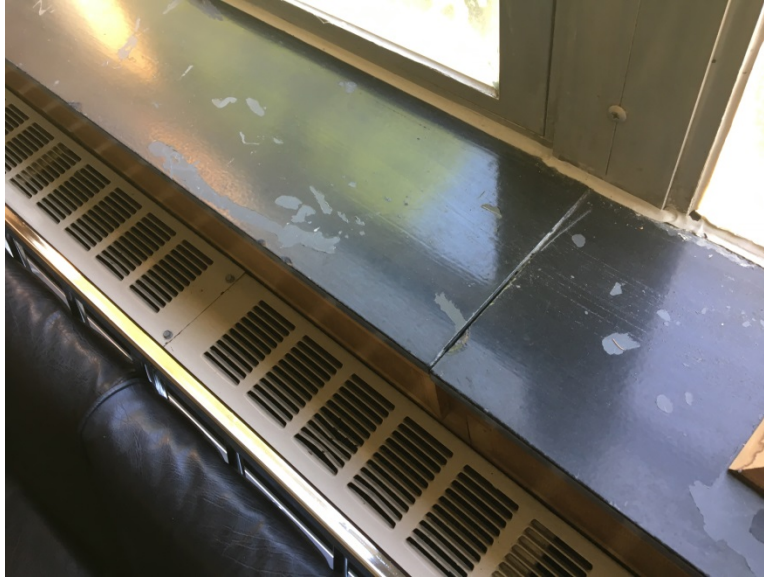
**Photograph 1:** Typical window sill, Room A1 (front office)

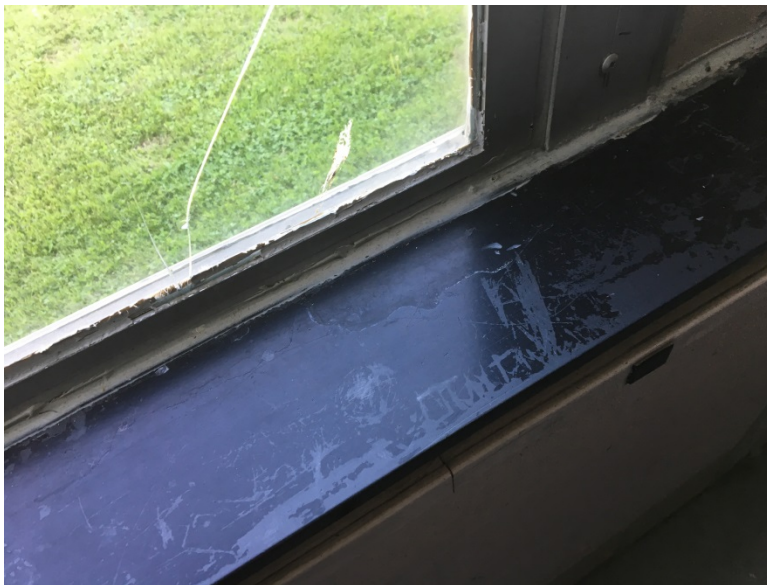
**Photograph 2:** Typical windowsill and caulking, Room A18

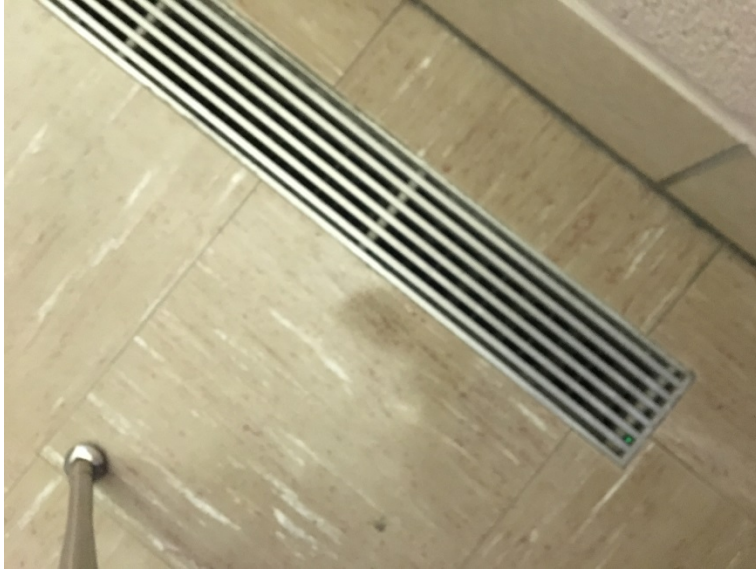
**Photograph 3:** Typical floor vent, Room A18

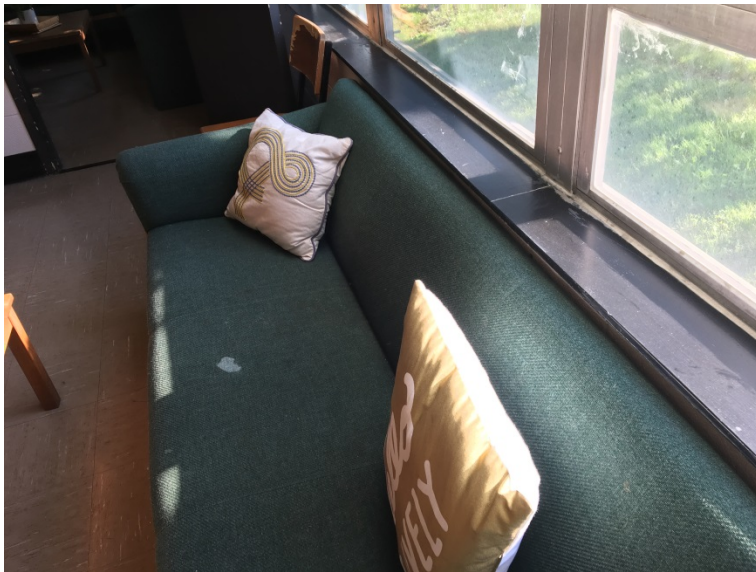
**Photograph 4:** Windowsill in Staff Lounge

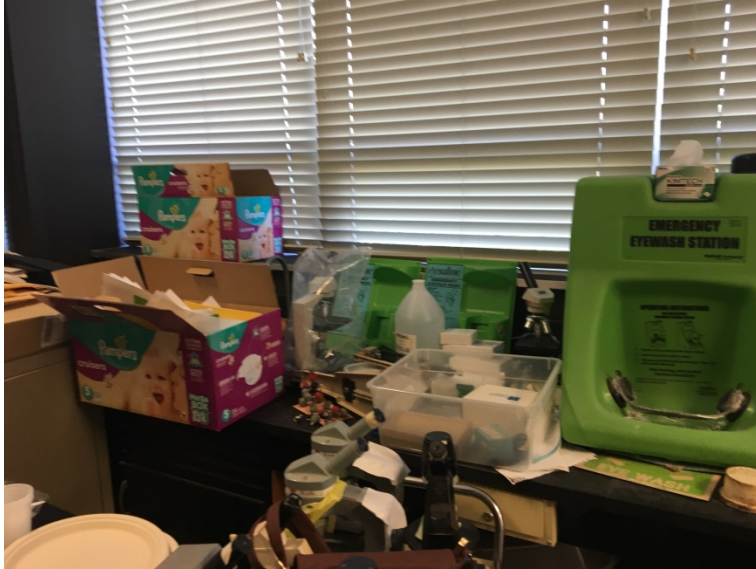
**Photograph 5:** Example of materials obstructing windowsill, science storeroom

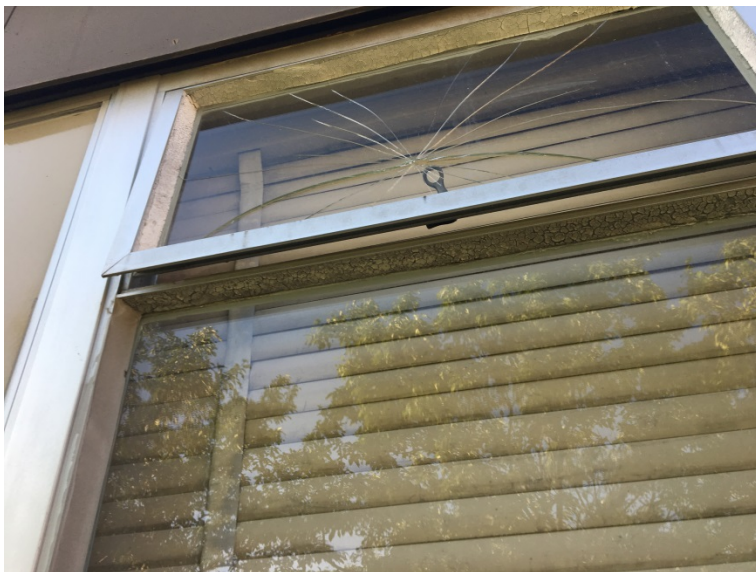
Exterior suspect caulking was likewise covered with new caulk to a height of eight feet above grade. No significant deterioration of the uncovered caulking at the tops of window units was observed.

**Photograph 6:** Typical caulked surfaces along window unit, building exterior
