June 25, 2018
File No. 5171-06-01

RE: May 2018 PCB BMP Quarterly Status Report
Doherty Memorial High School

Table 1 - Summary of BMP Observations
Doherty Memorial High School
299 Highland Street
Worcester, MA 01602
May 24, 2018

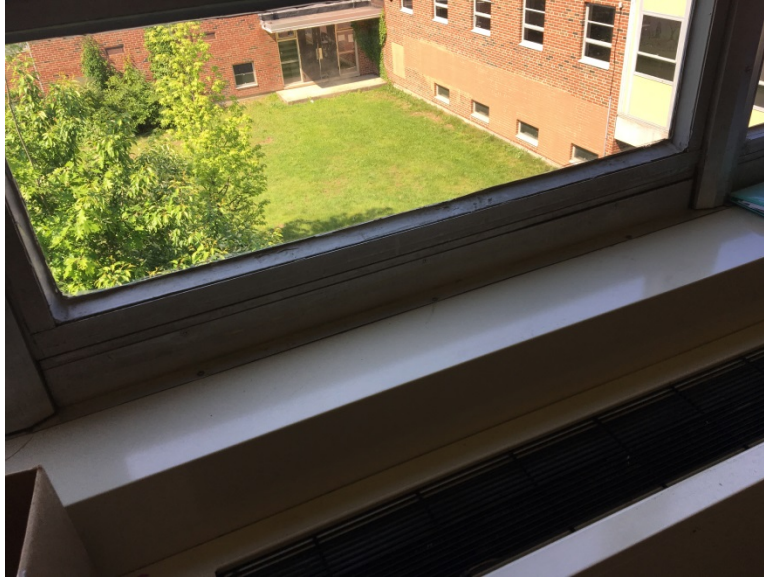
Photograph 1: Typical windowsill and Univent, Room 412

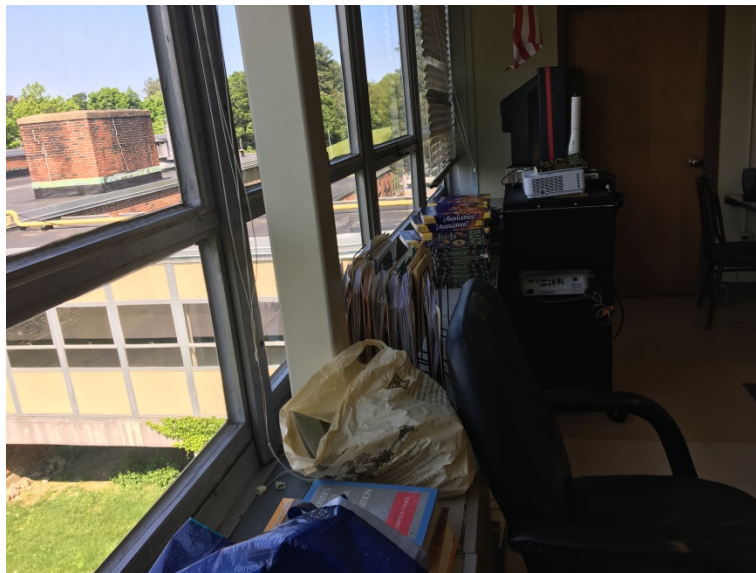
Photograph 2: Windowsill used for storage, Room 414

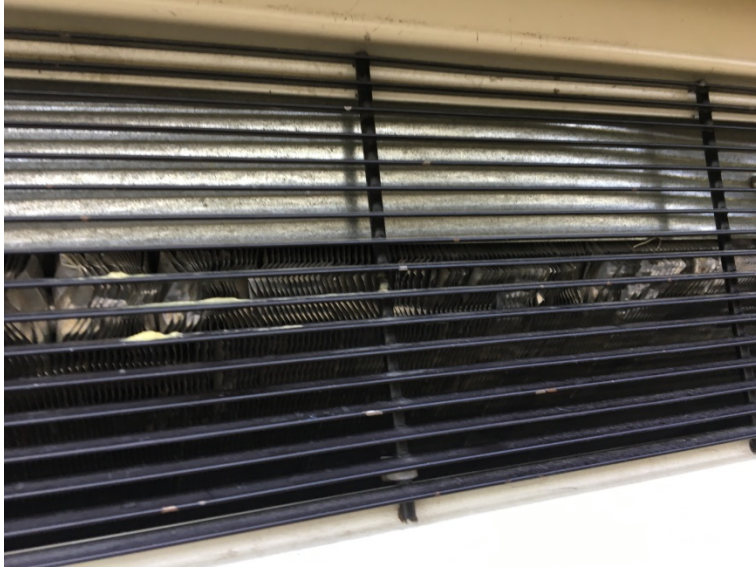
Photograph 3: Typical Univent grating, Room 424

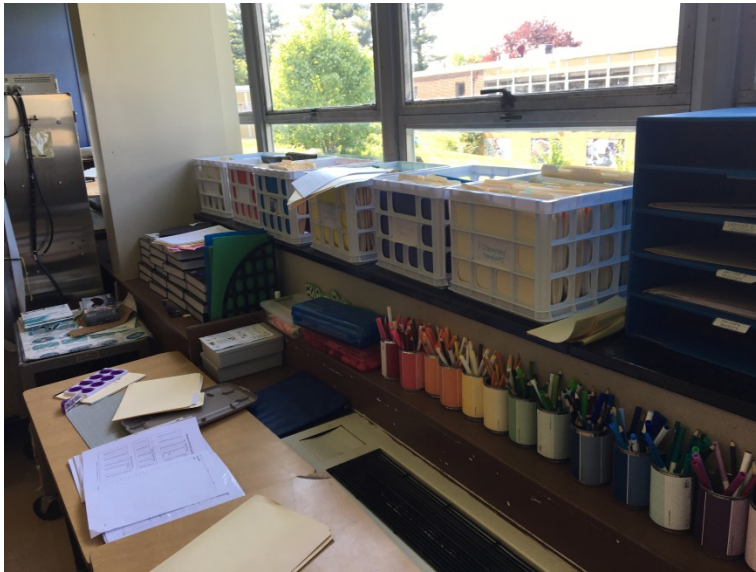
Photograph 4: Storage on windowsill, Room 320

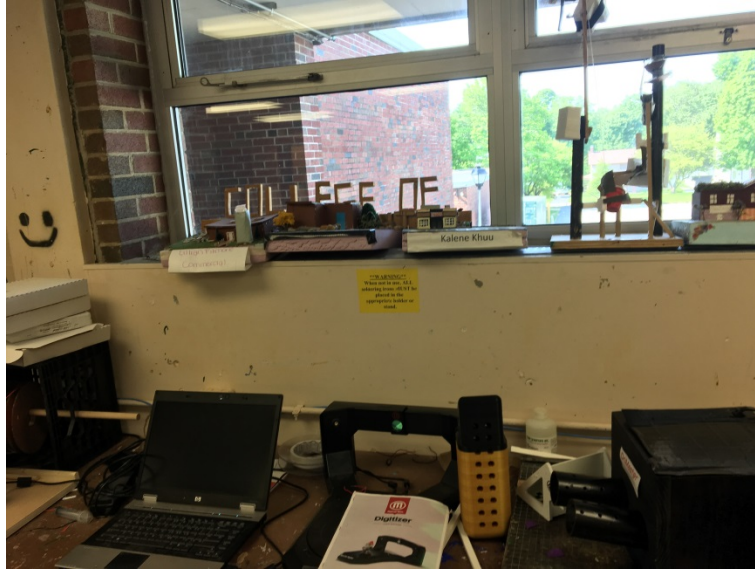
Photograph 5: Windowsill in engineering laboratory

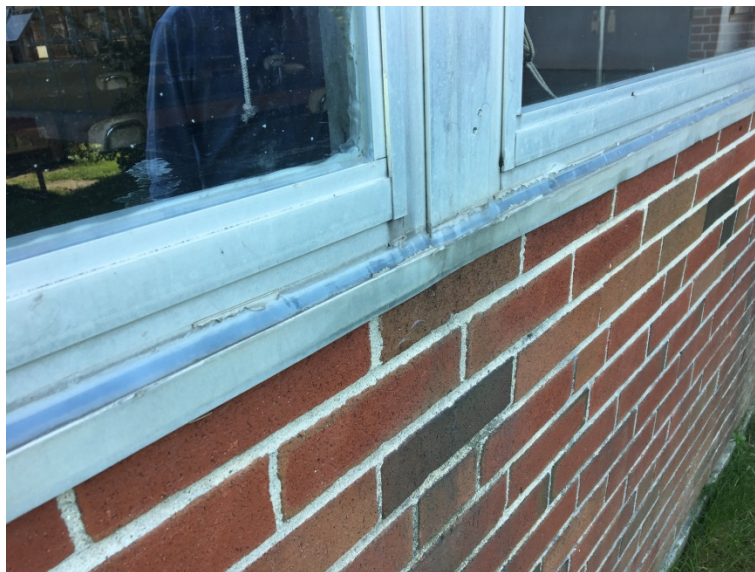
Photograph 6: Area of formerly disturbed caulk on ground floor north face of 400s wing.
