September 22, 2017
File No. 5171-06-01

RE: August 2017 PCB BMP Quarterly Examinations
Doherty Memorial High School

Table 1 - Summary of BMP Observations
Doherty Memorial High School
299 Highland Street
Worcester, MA 01602
August 21, 2017

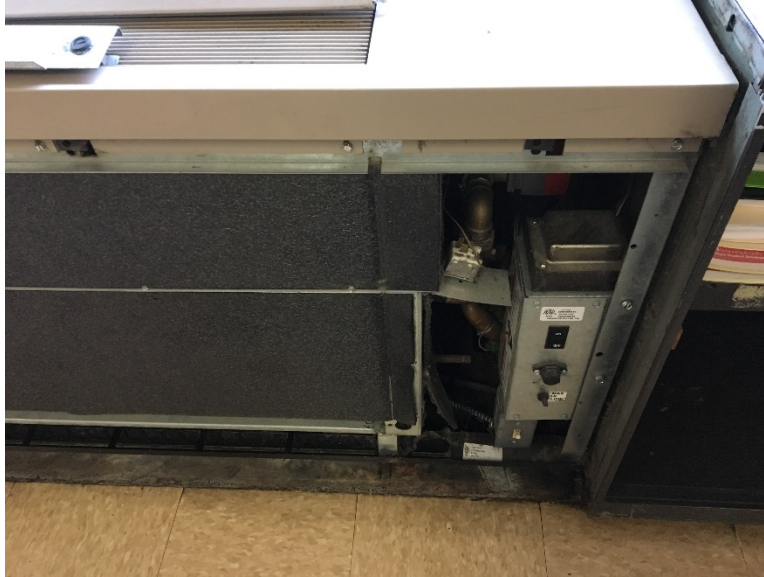
Photograph 1: Interior of Univent, Doherty Room 104

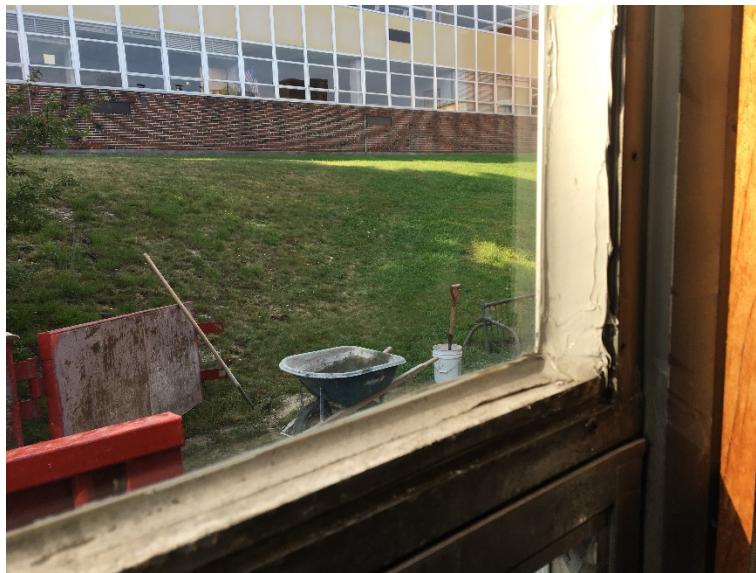
Photograph 2: Typical window caulk, Doherty Room 104

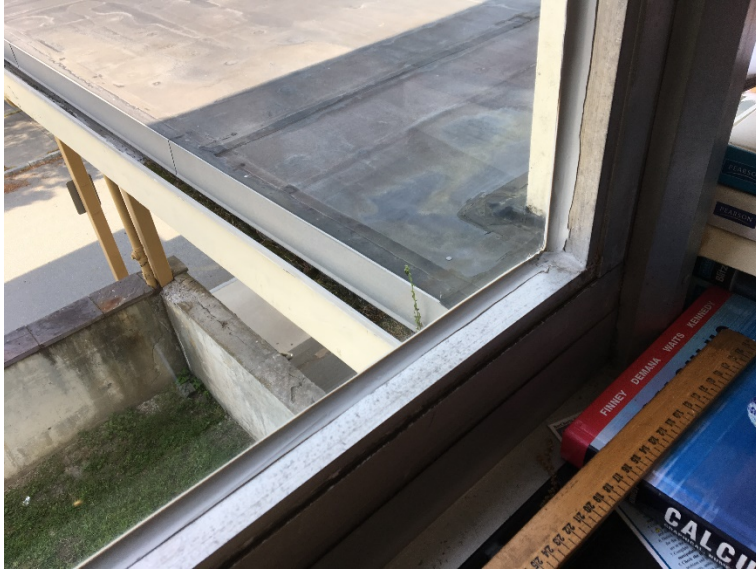
Photograph 3: Typical window caulk, Doherty Room 202

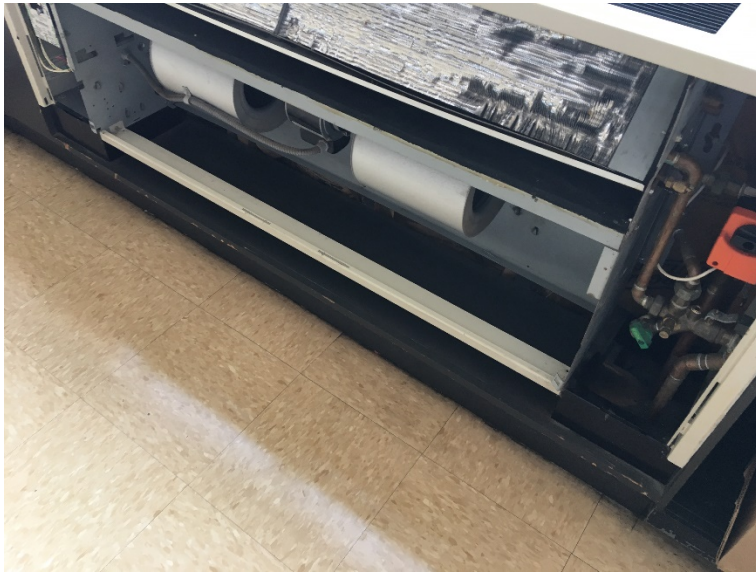
Photograph 4: Interior of Univent, Doherty Room 202

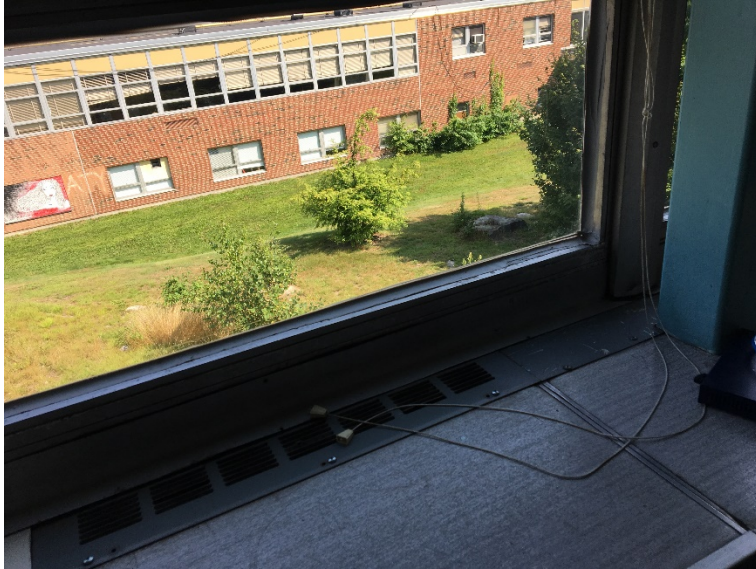
Photograph 5: Typical window caulk, Doherty Room 402

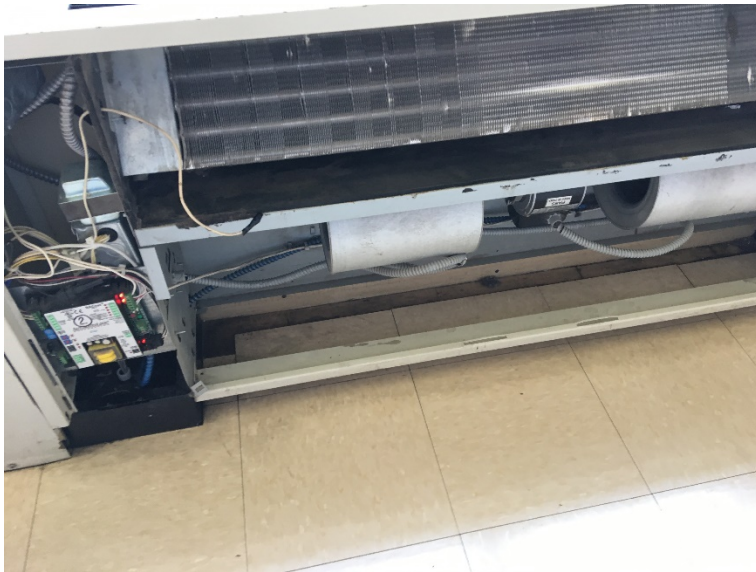
Photograph 6: Interior of Univent, Doherty Room 402

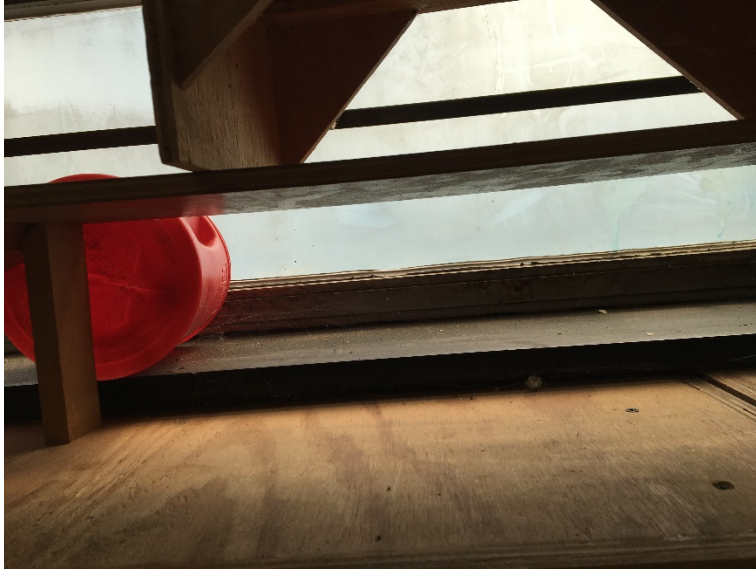
The overall quality of BMPs at Doherty was very good. The interior over-caulking was intact and in good condition in each of the spaces observed, and the uninvents were free of significant dust or visible oil leakage. Several rooms, mostly in the wood shop area, exhibited accumulated dust, but this appeared to consist mostly of recently generated sawdust. School maintenance staff indicated that windowsills and adjacent surfaces would be wet-wiped prior to the start of classes in accordance with School Committee policy.

Photograph 7: Accumulated sawdust in Doherty woodworking classroom

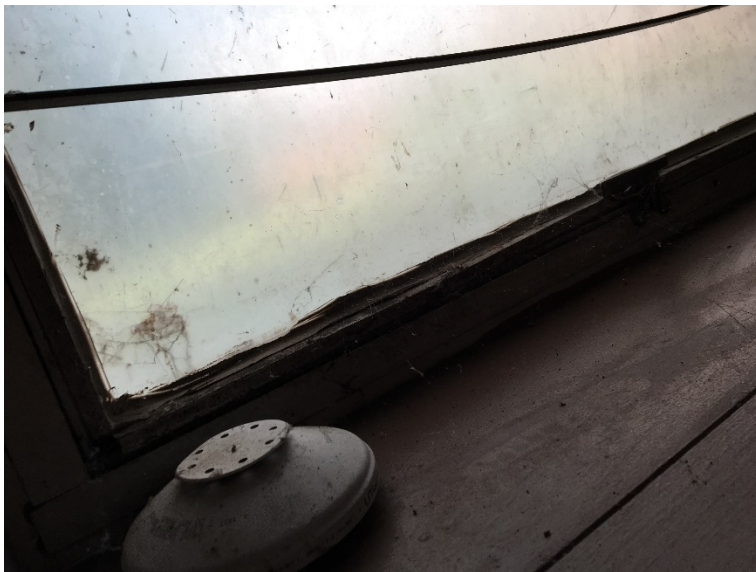
Photograph 8: Accumulated dust, Doherty room 301

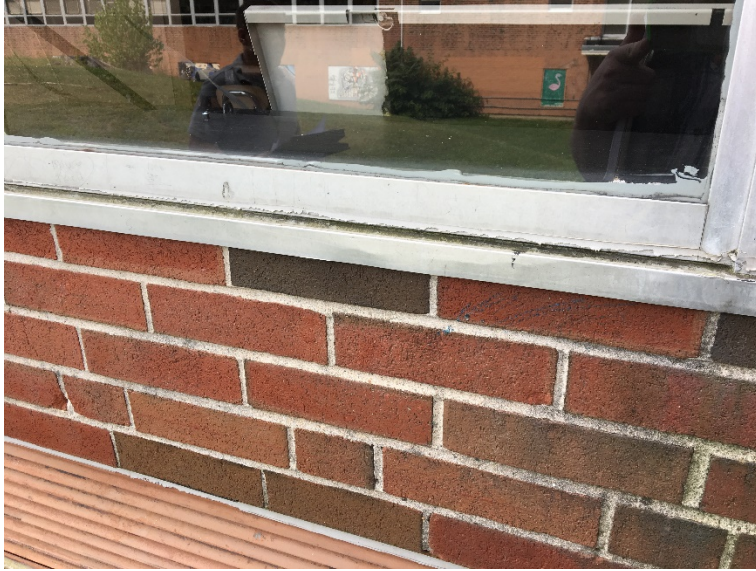
OTO observed that exterior windows along the courtyard face of rooms 316-328 in the southern wing of the building exhibited damaged or missing over-caulking. This area was brought to the attention of WPS staff. WPS staff told us on September 8, 2017 that the caulking had been repaired. Photographs of the repaired caulk are attached.

Photograph 9: Damaged exterior caulking, vicinity of Doherty rooms 316-328

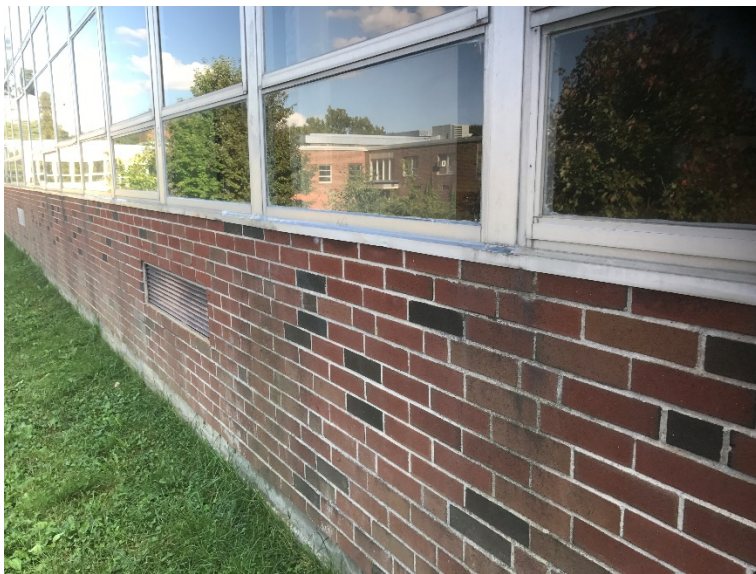
Photograph 10: Typical repaired caulking, vicinity of Doherty rooms 316-328
(photograph provided by WPS staff 9/8/2017)
