March 9, 2018
File No. 5171-06-01

RE: February 2018 PCB BMP Quarterly Status Report
Burncoat High School

Table 1 - Summary of BMP Observations
 Burncoat High School
 179 Burncoat Street
 Worcester, MA 01606
 February 20, 2018

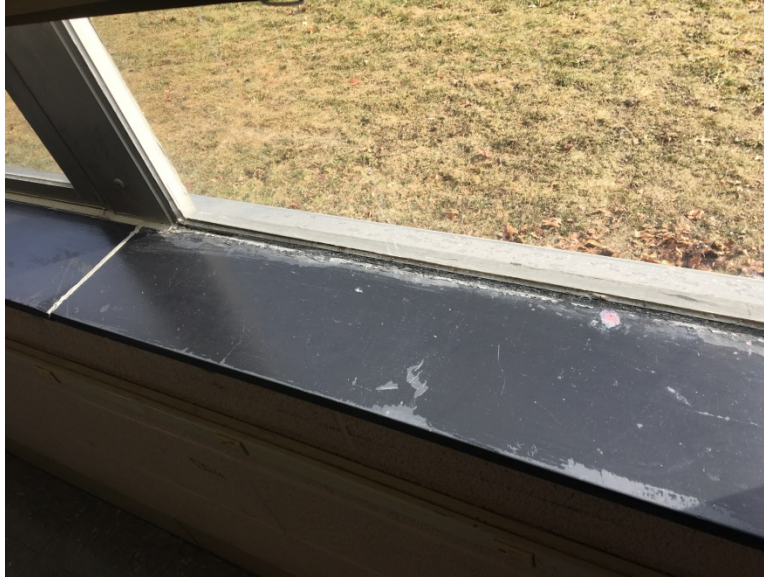
Photograph 1: Typical window unit, room A18

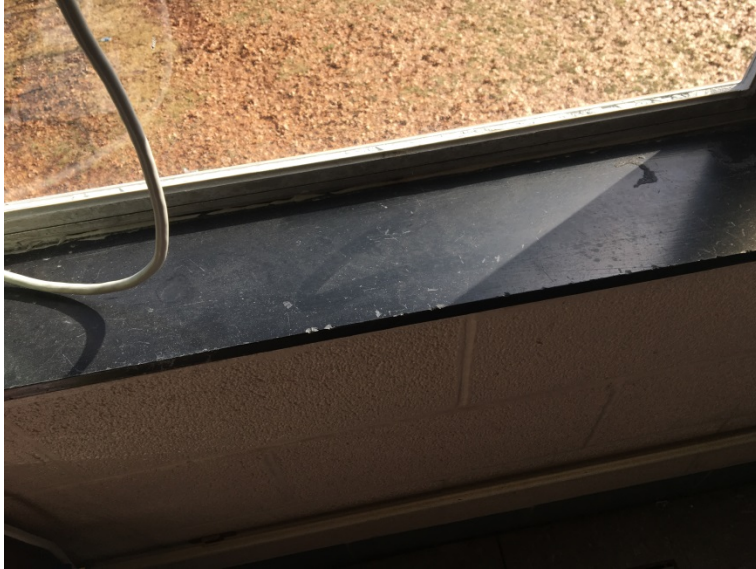
Photograph 3: Window and windowsill, room 10

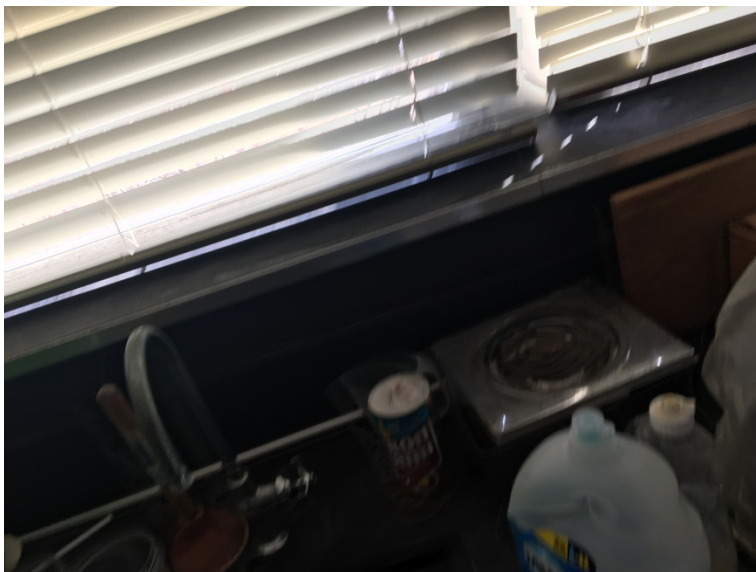
Photograph 4: Windowsill in chemical storage room

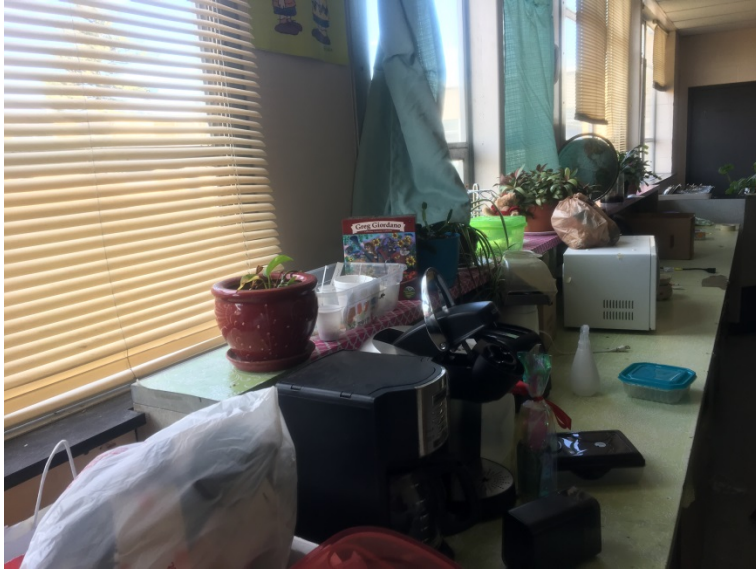
Photograph 5: Example of materials obstructing windowsill

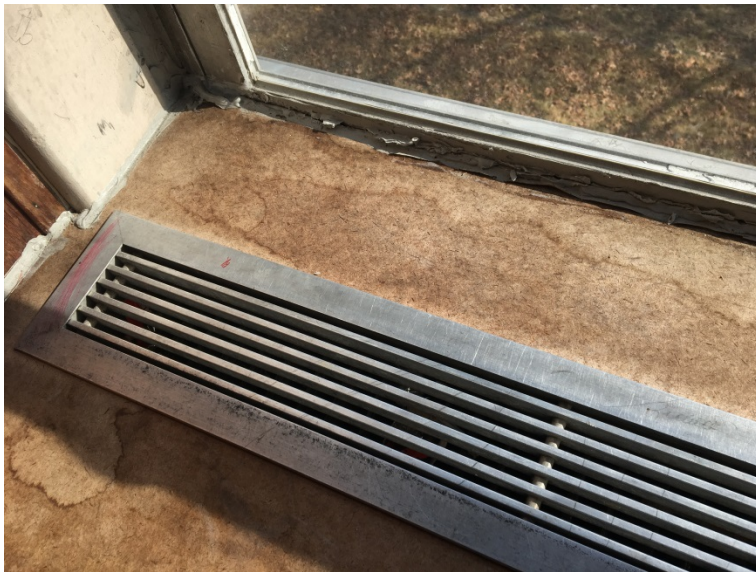
Photograph 6: Repaired caulk around window in room D6A
