March 9, 2018
File No. 5171-06-01

RE: February 2018 PCB BMP Quarterly Status Report
Doherty Memorial High School

Table 1 - Summary of BMP Observations
Doherty Memorial High School
299 Highland Street
Worcester, MA 01602
February 20, 2018

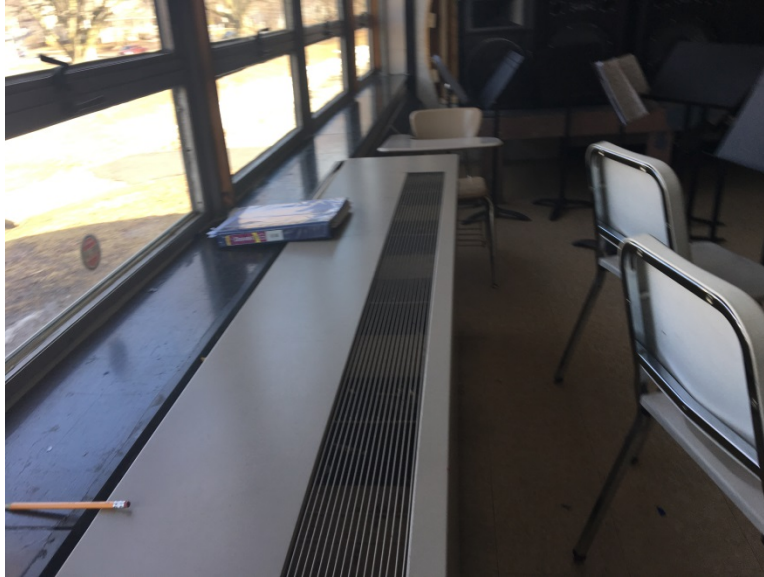
Photograph 1: Typical windowsill and Univent, Room 101

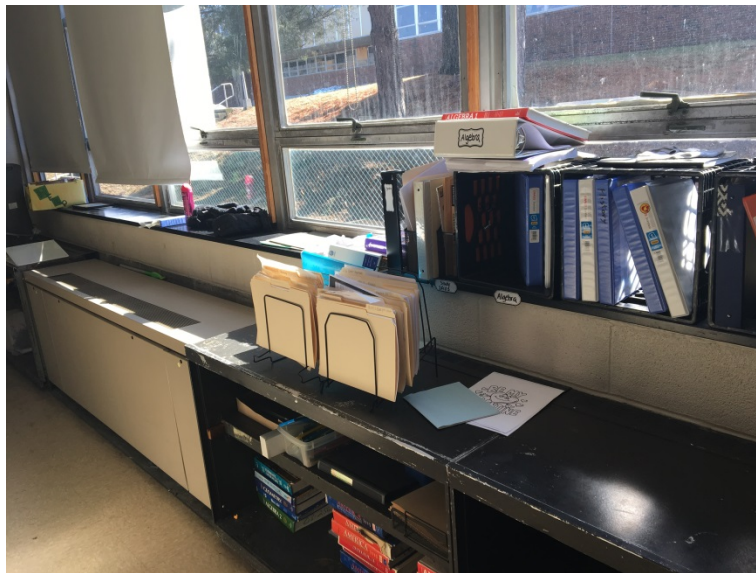
Photograph 2: Windowsill used for storage, Room 104

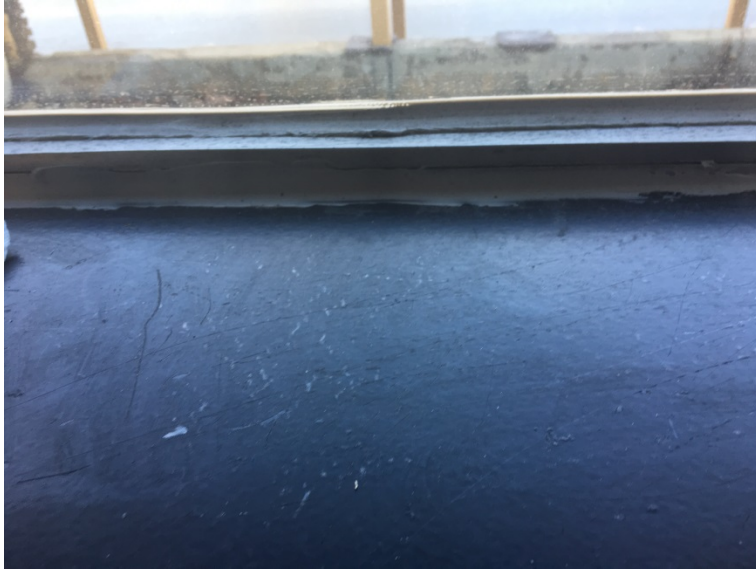
Also in 2012, WPS encapsulated the suspect PCB containing caulk around all of the windows at Doherty with an additional thick layer of non-PCB caulk. We observed this over-caulking in each room we visited and found that it was intact and in good condition. This over-caulking is amended on an as-needed basis to maintain its condition.

Photograph 3: Typical overcaulking

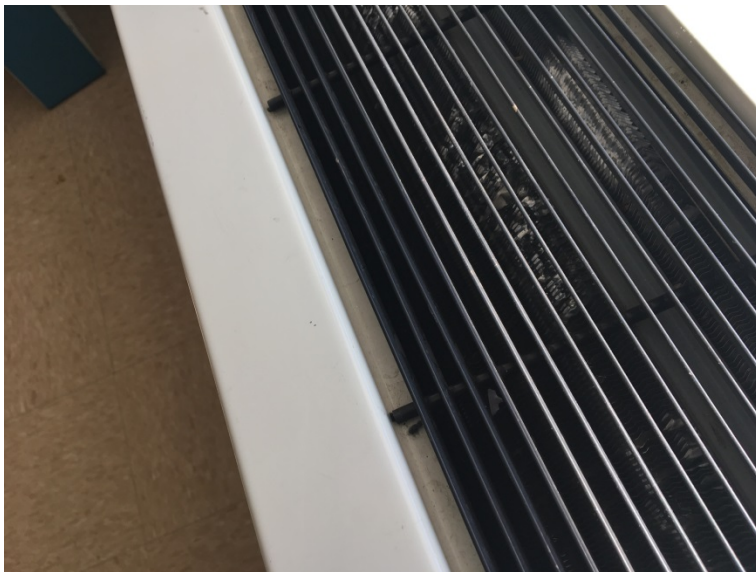
Photograph 4: Typical Univent condition. Room 310

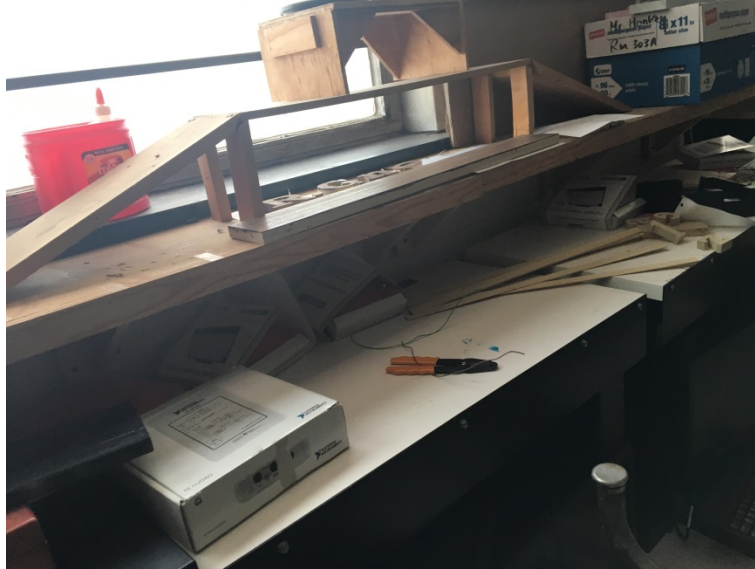
Photograph 5: Engineering classroom

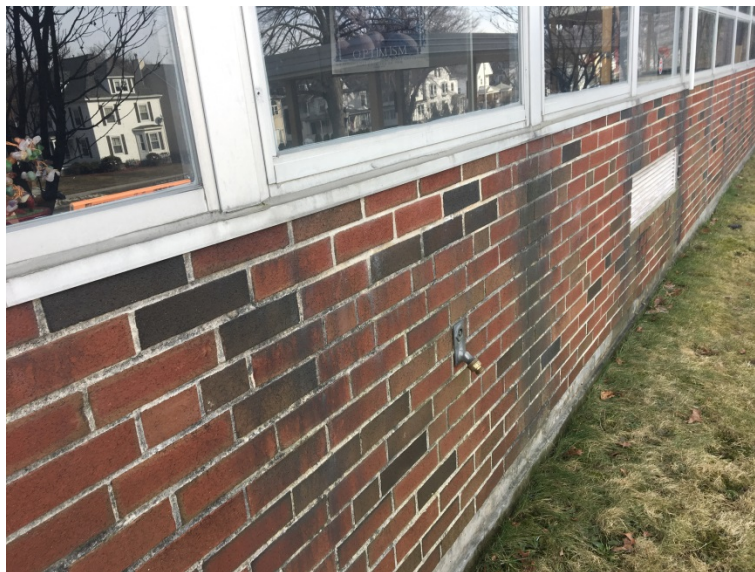
Photograph 6: Typical condition of exterior caulk
