December 27, 2017
File No. 5171-06-01

RE: November 2017 PCB BMP Quarterly Status Report
Burncoat High School

Table 1 - Summary of BMP Observations
 Burncoat High School
 179 Burncoat Street
 Worcester, MA 01606
 November 22, 2017

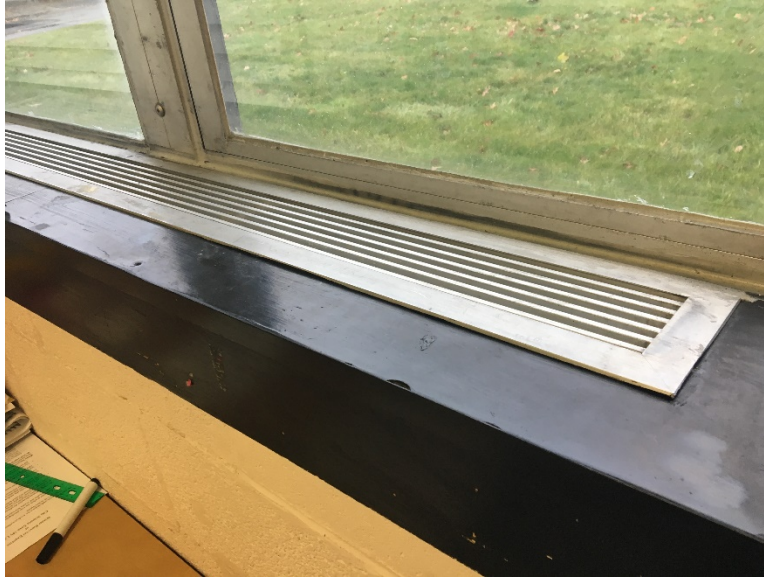
Photograph 1: Typical window unit, room E-5

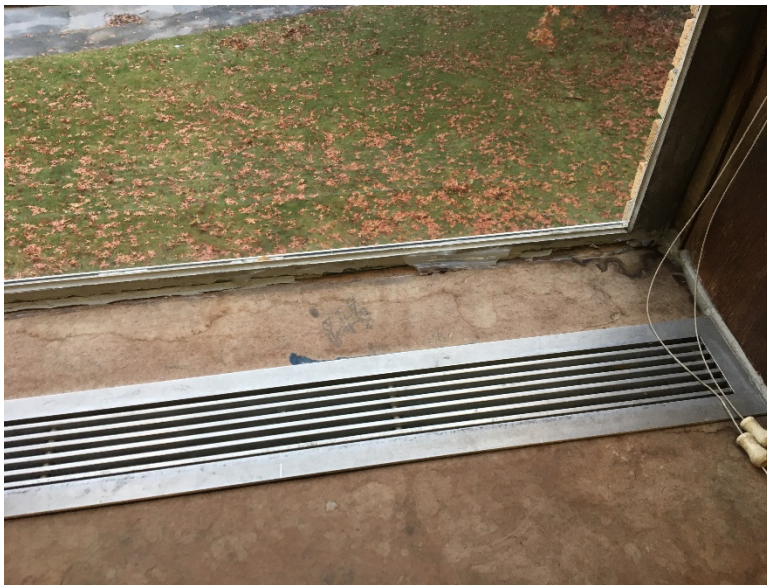
Photograph 2: Caulking torn by opening window, room D6A

now appear to have been locally damaged. When these areas were pointed out, the WPS staff accompanying OTO indicated that these areas would be addressed as part of routine maintenance.

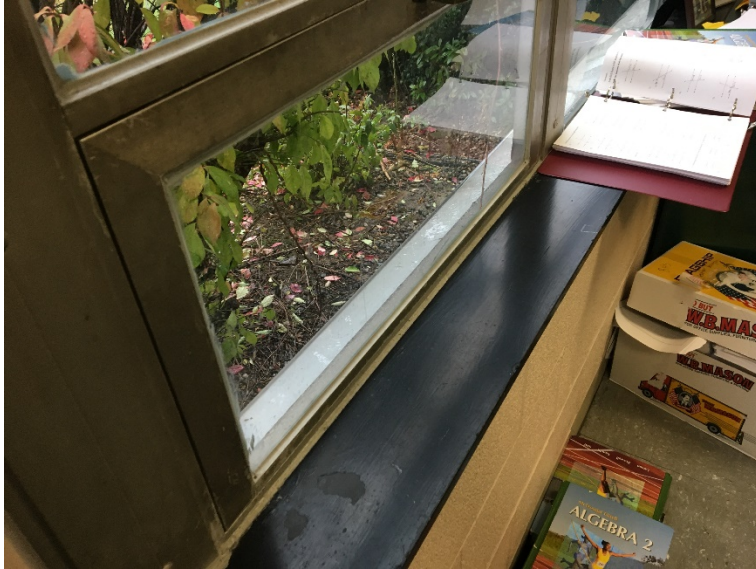
Photograph 3: Window and windowsill, room D3

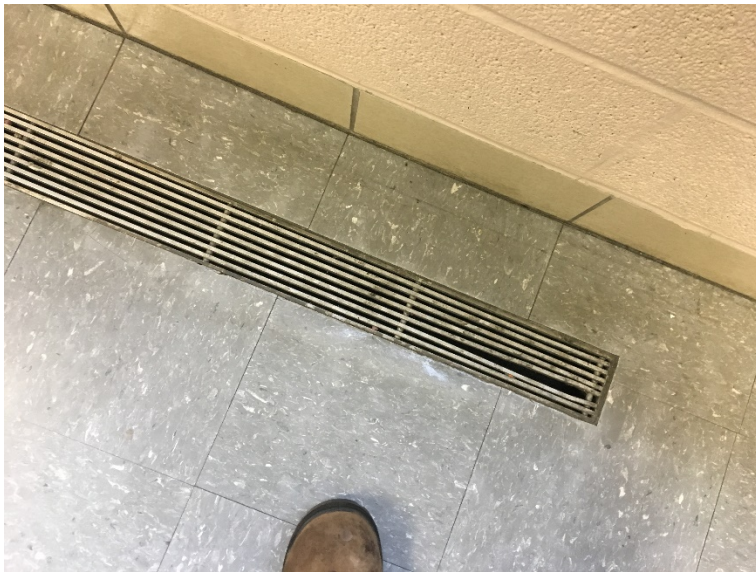
Photograph 4: Typical plenum vent in floor, room D3

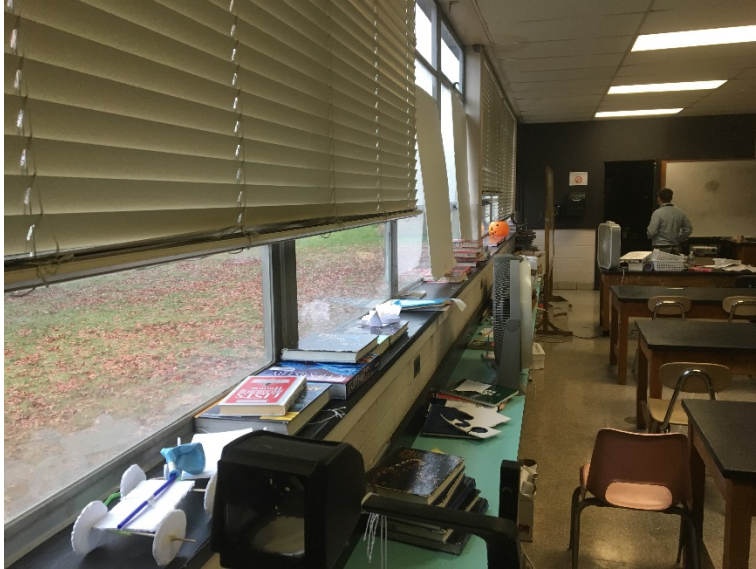
The spaces observed exhibited little dust, but we note that the storage of classroom materials on the windowsills in the classroom spaces creates obstacles for the routine cleanings. These regular cleanings are an important component of the WPS BMP program. The placement of classroom items such as dioramas or rows of textbooks on the windowsills creates difficult to clean areas that promote the accumulation of dust and cannot be wet-wiped or effectively HEPA-vacuumed.

Photograph 5: Windowsill obstructed by book storage (typical)

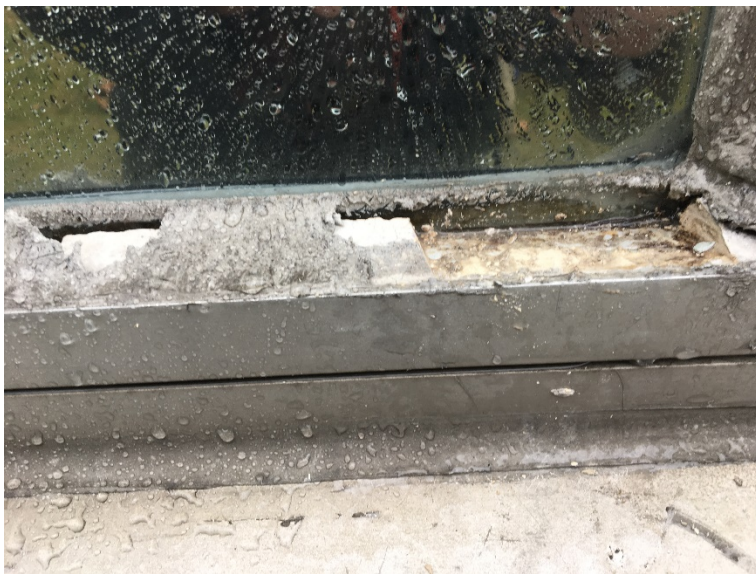
Photograph 6: Typical window caulk, viewed during sampling by EHI.
