January 3, 2018
File No. 5171-06-01

RE: December 2017 PCB BMP Quarterly Status Report
Doherty Memorial High School

Table 1 - Summary of BMP Observations
Doherty Memorial High School
299 Highland Street
Worcester, MA 01602
November 22 and December 7, 2017

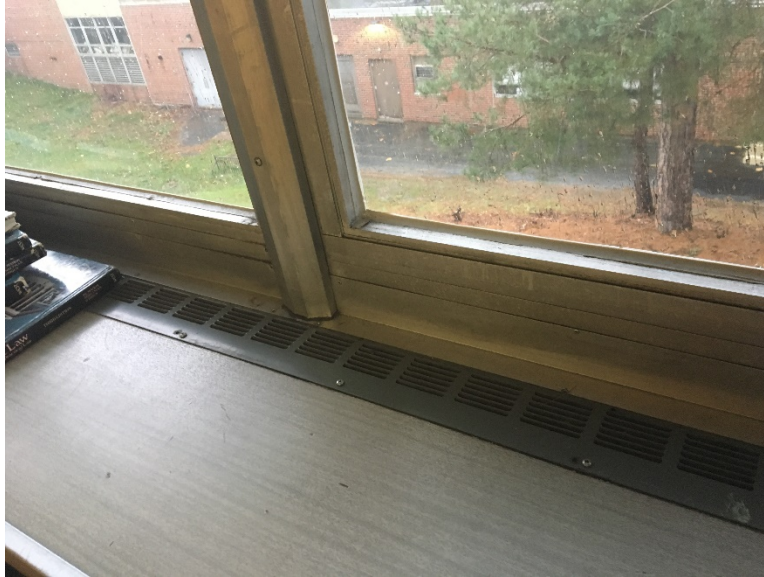
Photograph 1: Typical window unit, room 402

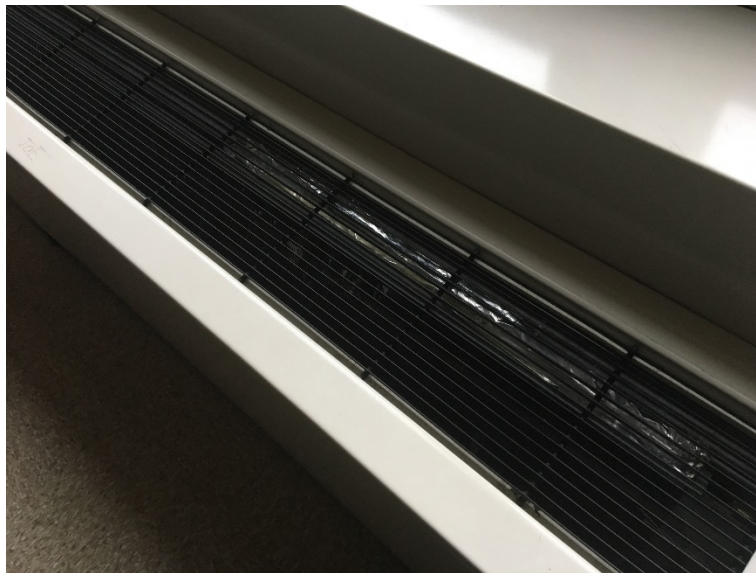
Photograph 2: Typical uninvent exhaust, room 402

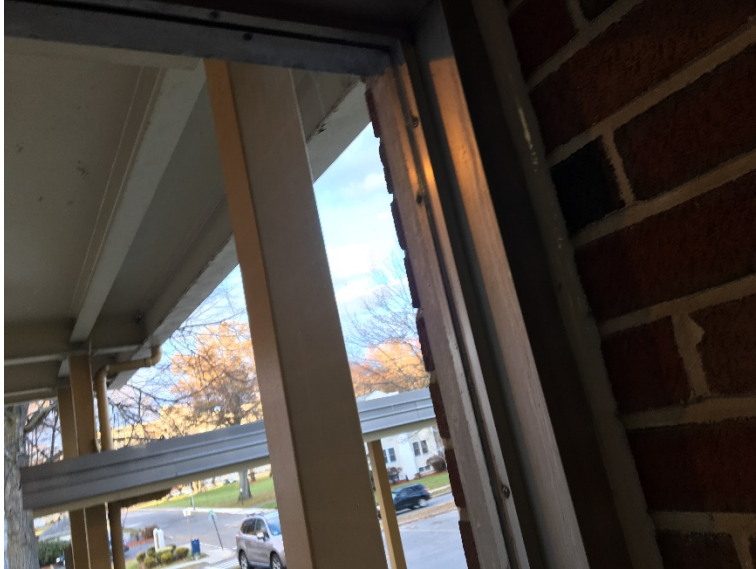
Photograph 3: Typical caulk around exterior door unit, main doorway by cafeteria

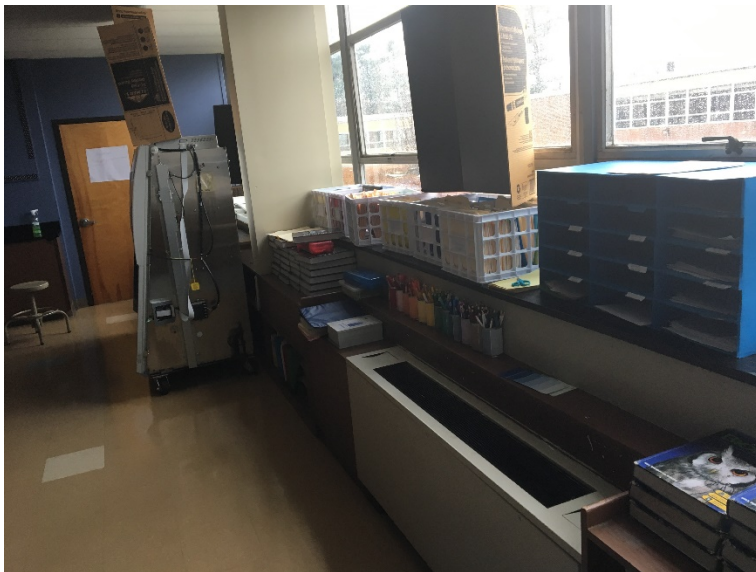
The spaces observed exhibited little dust, but we note that the storage of classroom materials on the windowsills in the classroom spaces creates obstacles for the routine cleanings. These regular cleanings are an important component of the WPS BMP program. The placement of classroom items such as dioramas or rows of textbooks on the windowsills create difficult to clean areas that promote the accumulation of dust and cannot be wet-wiped or effectively HEPA-vacuumed.

Photograph 4: Windowsill obstructed by storage (typical)

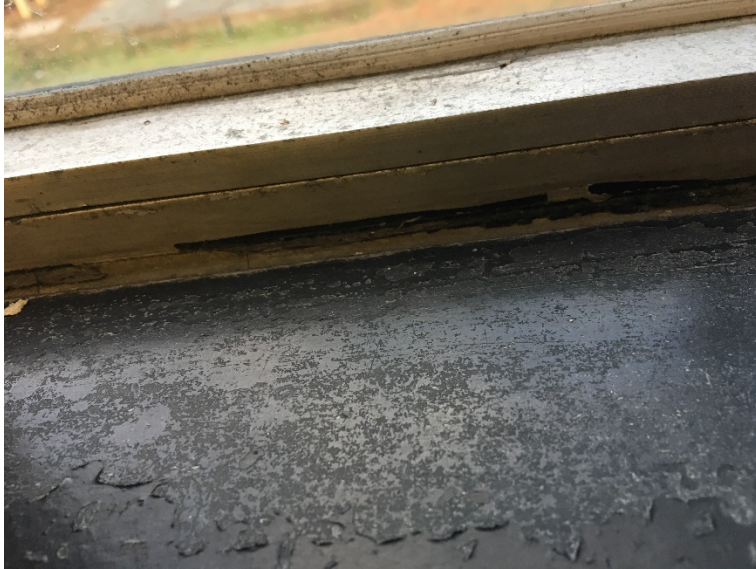
Photograph 5: Typical area in need of recaulking, room 103

intact appears to have been locally damaged. WPS staff accompanying OTO during the Doherty observations indicated that these areas would be addressed as part of routine maintenance.

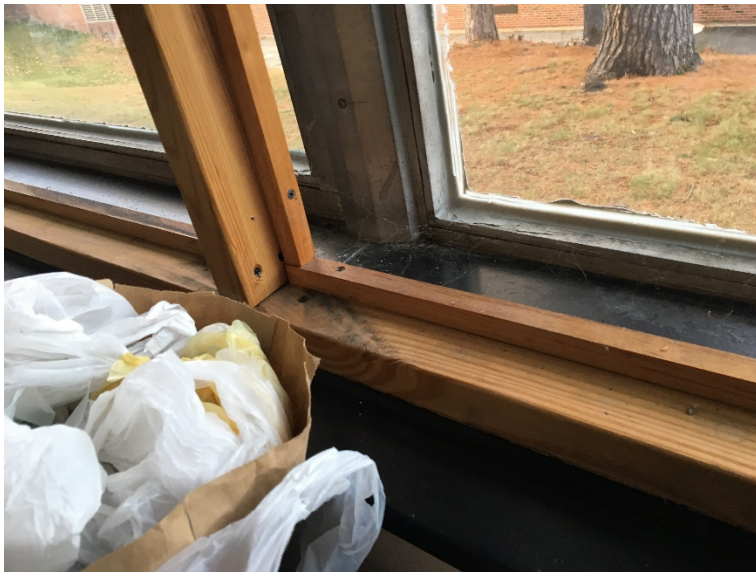
Photograph 6: accumulated dust and cobwebs, room 306
