RE: August 2017 PCB BMP Quarterly Examinations
Burncoat High School

Table 1 - Summary of BMP Observations
 Burncoat High School
 179 Burncoat Street
 Worcester, MA 01606
 August 21, 2017

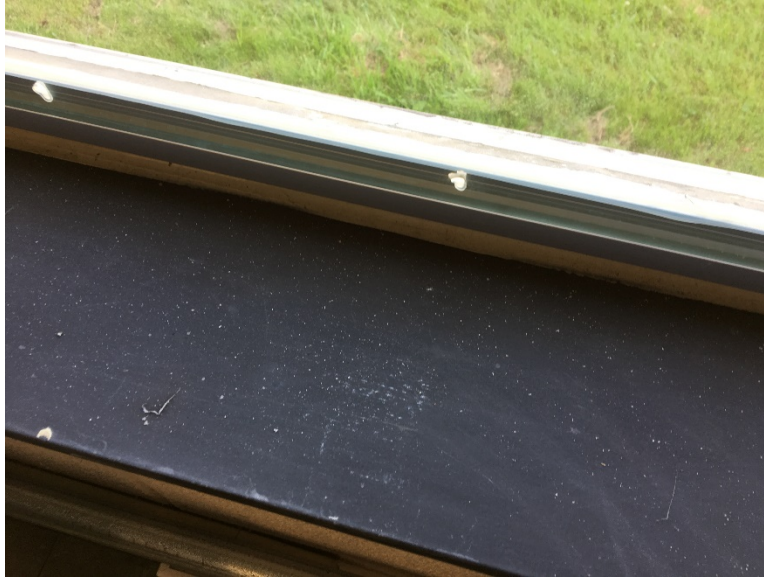
Photograph 1: Typical window caulk, Burncoat room A6

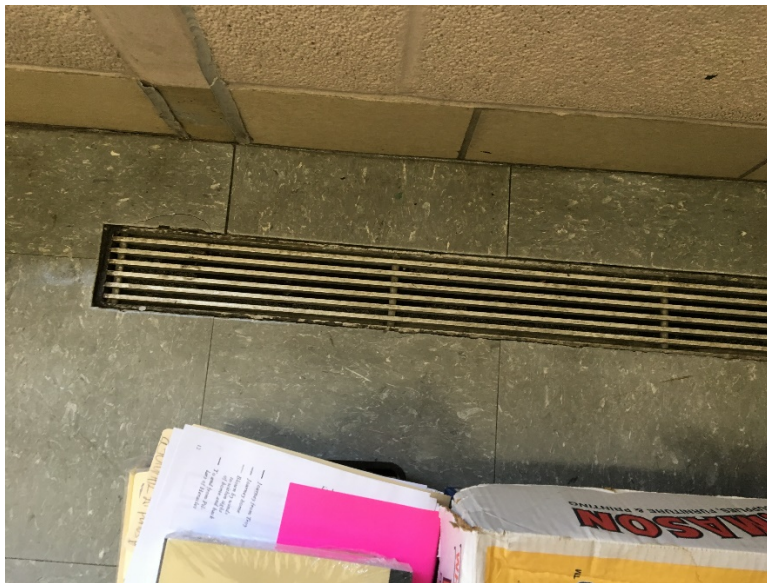
Photograph 2: Typical plenum vent in floor, Burncoat room A6

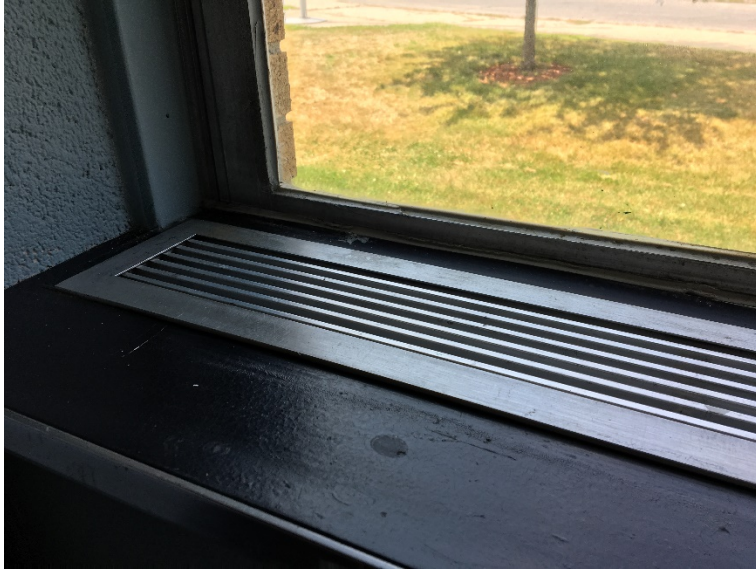
Photograph 3: Plenum vent in library

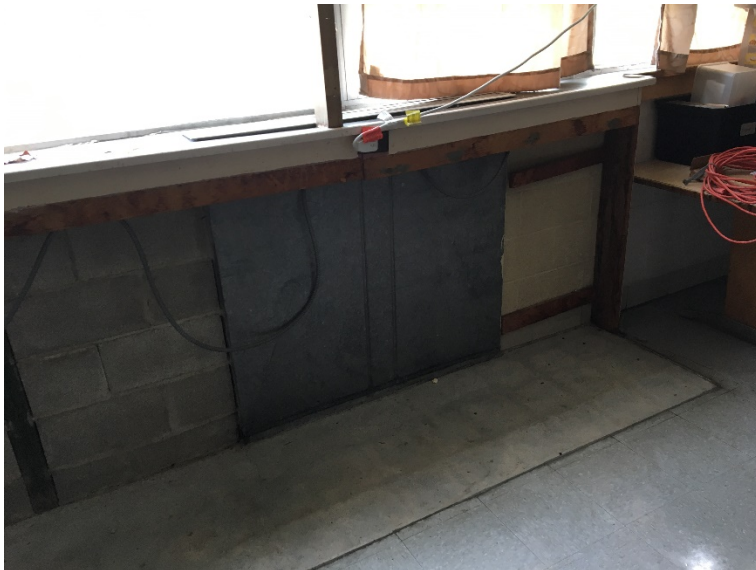
Photograph 4: Counter along window demolished as part of asbestos abatement, showing plenum riser, Burncoat room F-8.

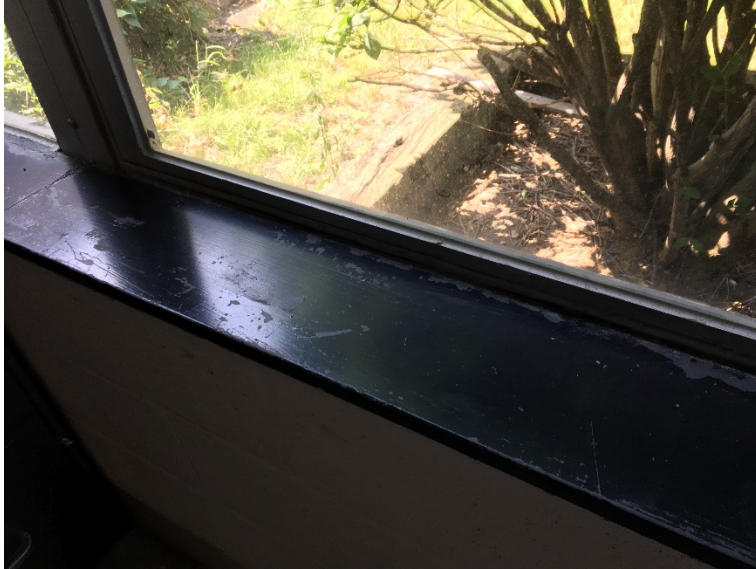
The overall quality of BMPs was very good for most of Burncoat. The interior over-caulking was intact in the spaces observed except for minor pieces of material missing from rooms D6A, E4 and F2. The vents for the sub-floor heating plenum were free of significant dust and debris.

Photograph 5: Area of absent caulking, Burncoat room F2.

WPS staff indicated on September 19, 2017 that the missing over-caulk in rooms D6A, E4 and F2 had been restored, along with the library, where no original caulking was present, but where new caulk was applied to seal an air gap. Over-caulking was also applied to the H-wing, which is occupied by the music department. The music department is actually located in the Burncoat Middle School building.

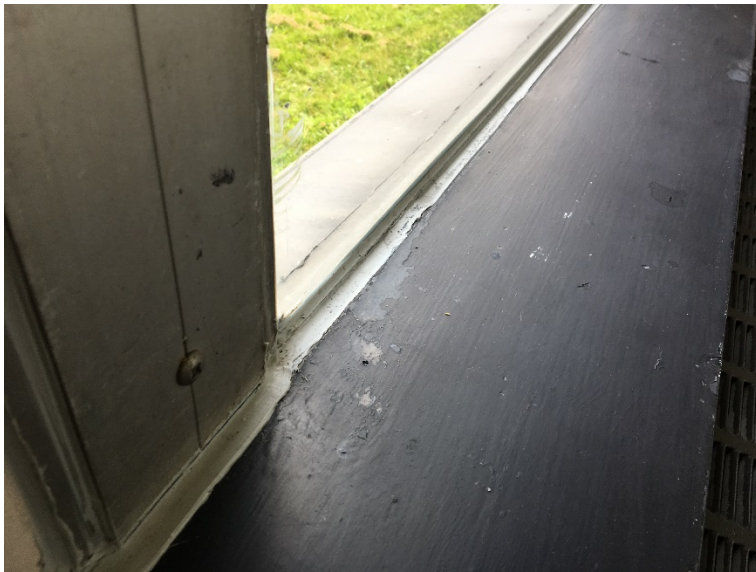
Photograph 6: Typical window caulk, Burncoat room C4
