September 17, 2018
File No. 5171-06-01

RE: September 2018 - PCB BMP Quarterly Status Report
Doherty Memorial High School

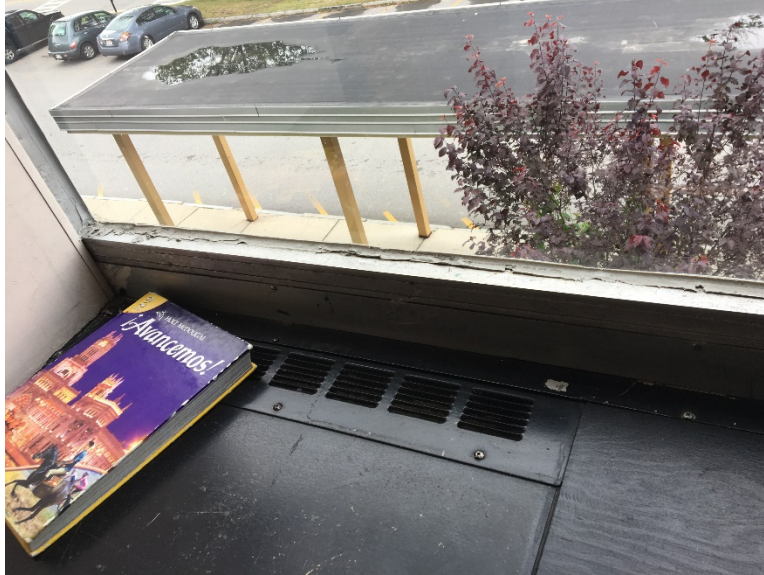
Photograph 1: Typical windowsill, Room 202

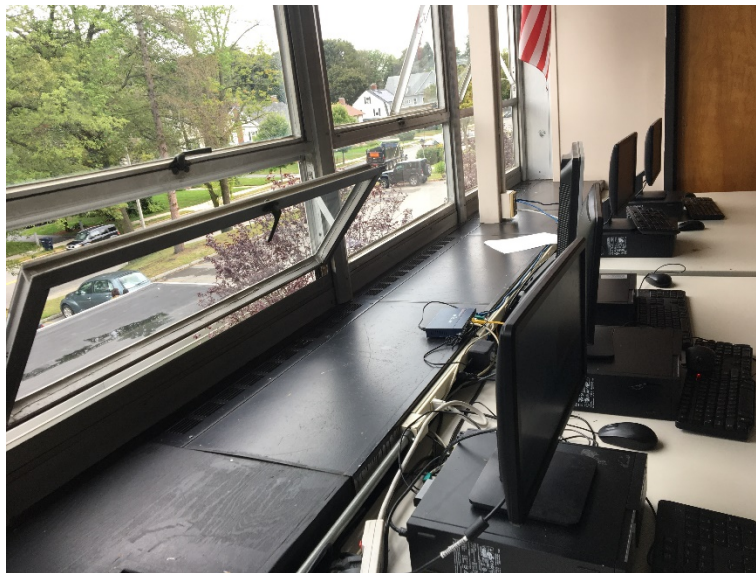
Photograph 2: Typical windowsill, Room 206

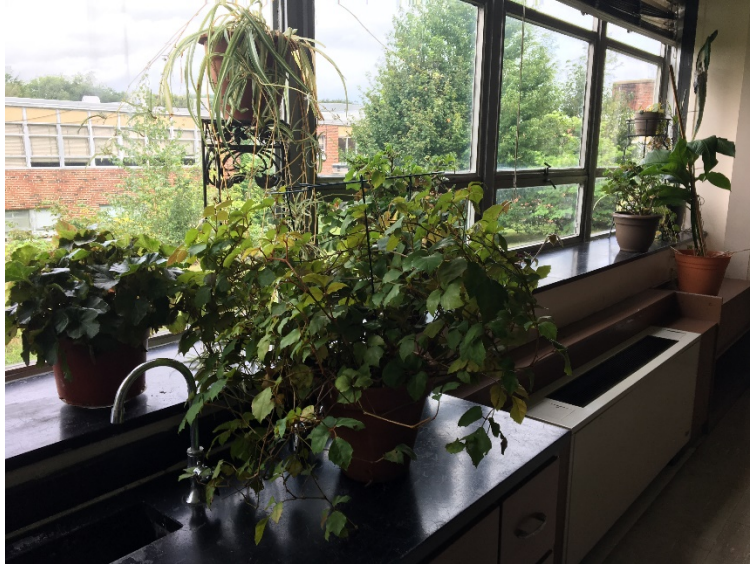
Photograph 3: Plants on windowsill, Room 322

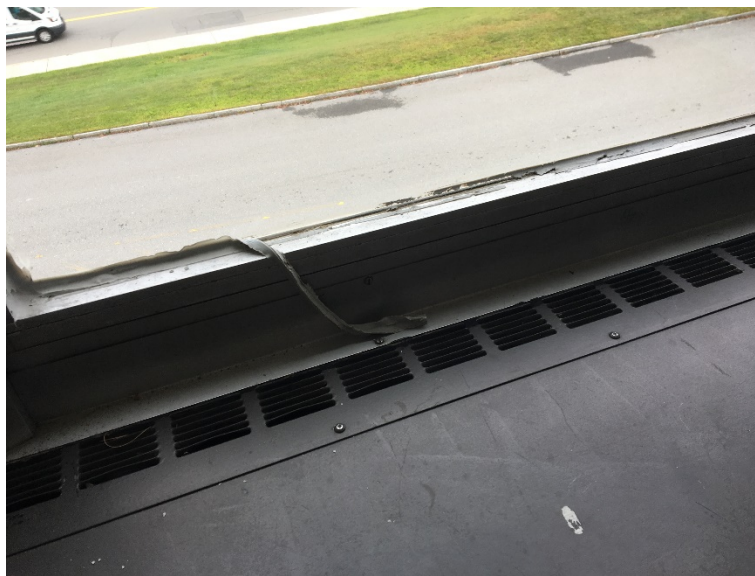
Photograph 4: Damaged caulk, Room 210

Also in 2012, WPS encapsulated the suspect PCB containing caulk around the windows at Doherty with an additional thick layer of non-PCB caulk. We observed this over-caulking in each room we visited and found that it was intact and in good condition. This over-caulking is repaired on an as-needed basis to maintain its condition.

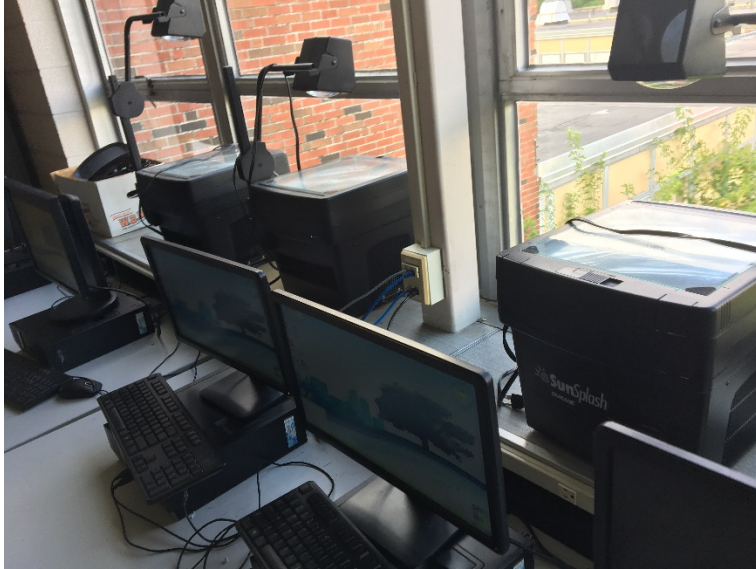
Photograph 5: Windowsill, Room 416

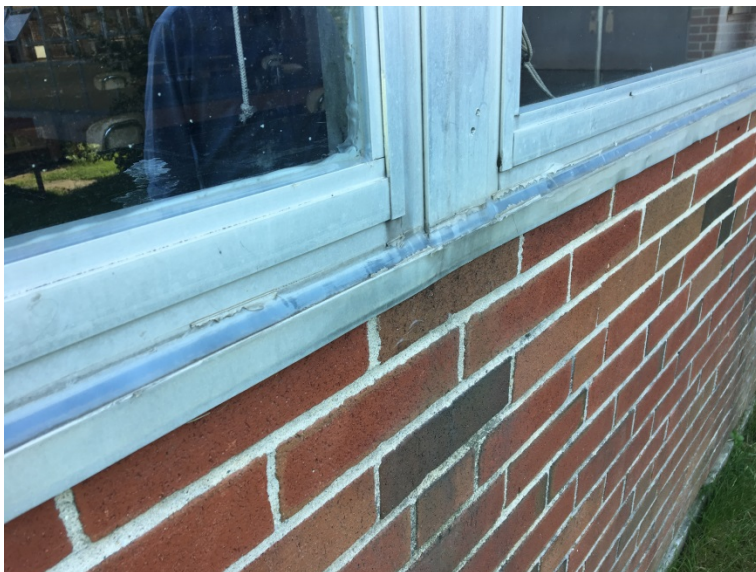
Exterior suspect caulking was likewise covered with new caulk to a height of eight feet above grade. Only limited areas of uncoated caulk are present on the exterior, primarily where the metal window units meet the brick facing. No significant deterioration of the uncovered caulking at the tops of window units was observed.

Photograph 6: Area of formerly disturbed caulk on ground floor north face of 400s wing.
