September 19, 2018
File No. 5171-06-01

RE: September 2018 - PCB BMP Quarterly Status Report
Burncoat High School

Table 1 - Summary of BMP Observations
 Burncoat High School
 179 Burncoat Street
 Worcester, MA 01606
 September 11, 2018

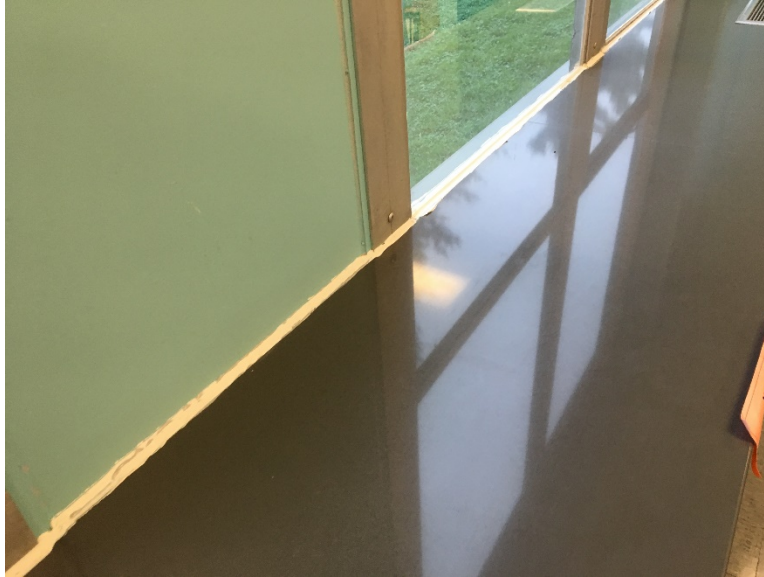
Photograph 1: Typical window sill, library

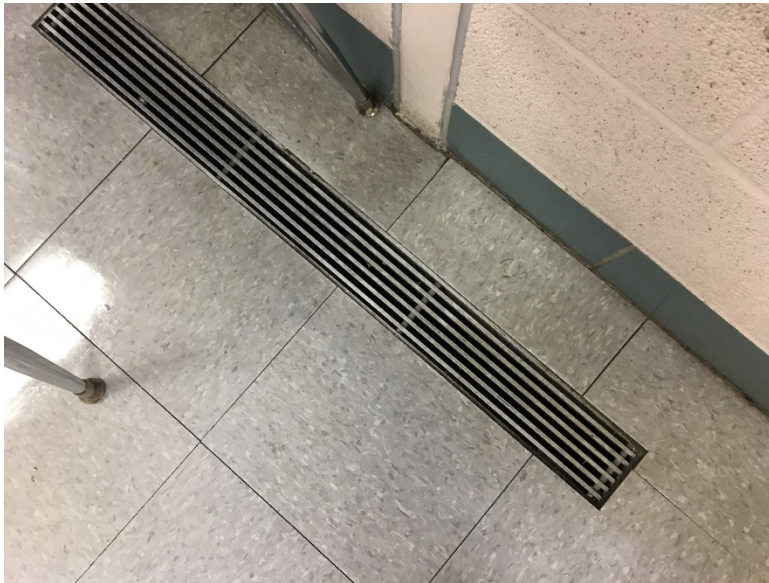
Photograph 2: Typical plenum vent, Room C19

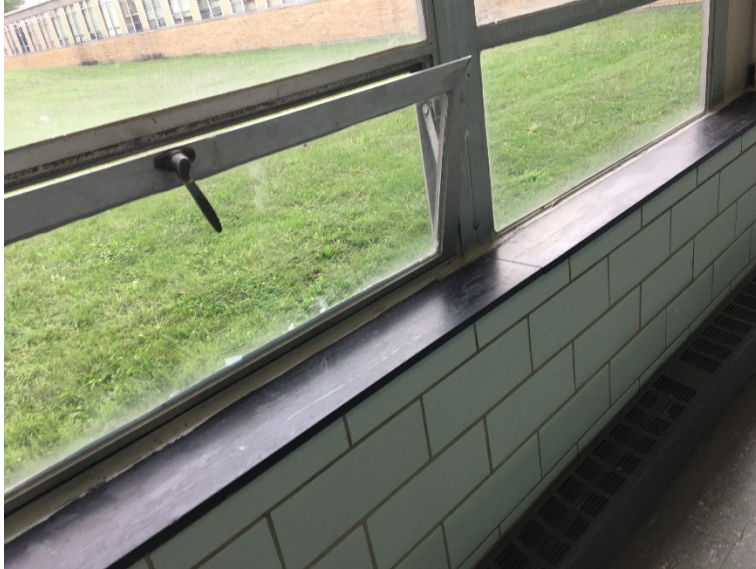
Photograph 3: Typical hallway window unit

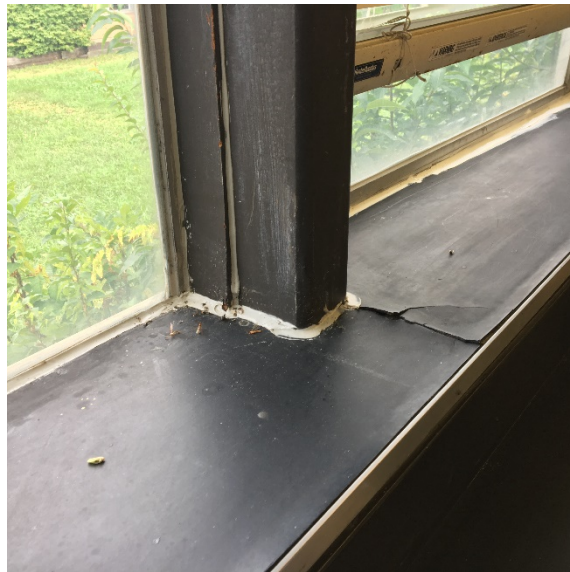
Photograph 4: Windowsill in Room C21

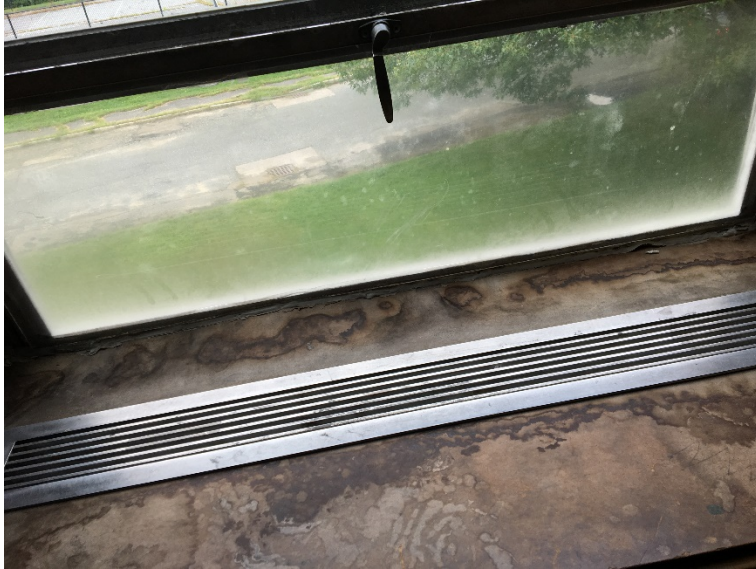
Photograph 5: Windowsill in room D6A

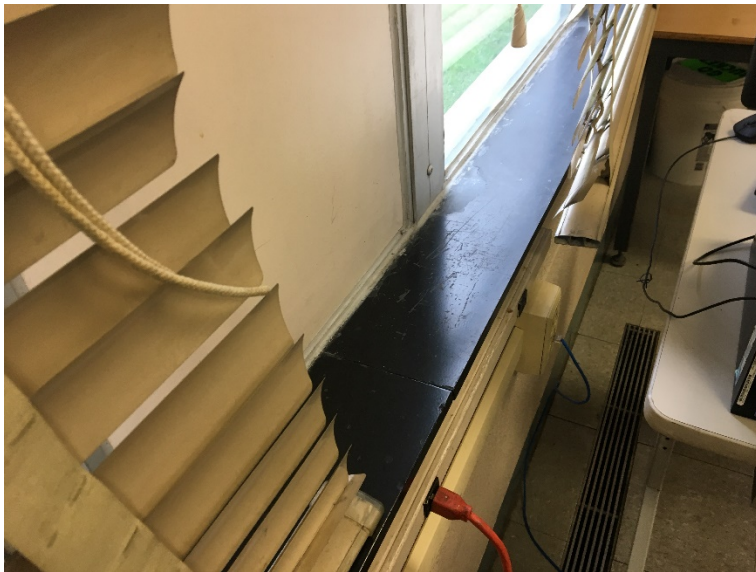
Photograph 6: Windowsill and blinds, Room C4
