December 4, 2018  
File No. 5171-06-01

RE: November 2018 - PCB BMP Quarterly Status Report  
Burncoat High School

Table 1 - Summary of BMP Observations  
 Burncoat High School  
 179 Burncoat Street  
 Worcester, MA 01606  
 November 21, 2018

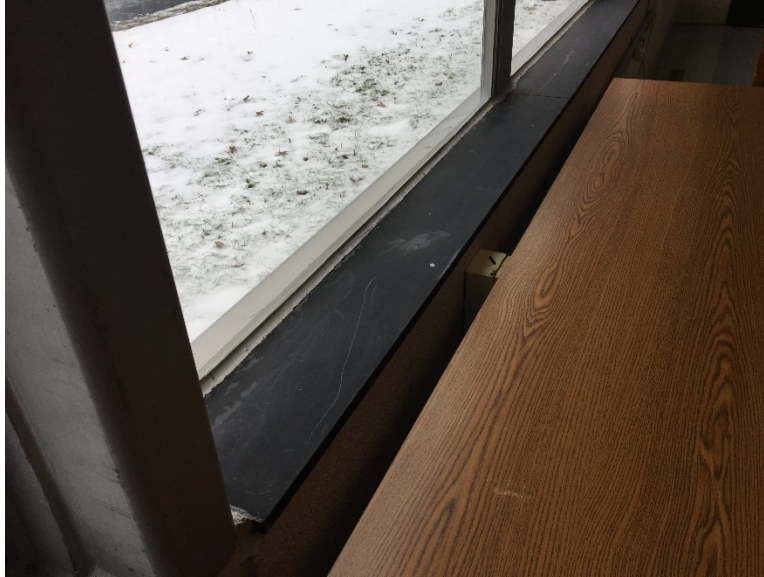
**Photograph 1:** Typical window sill, Room A6

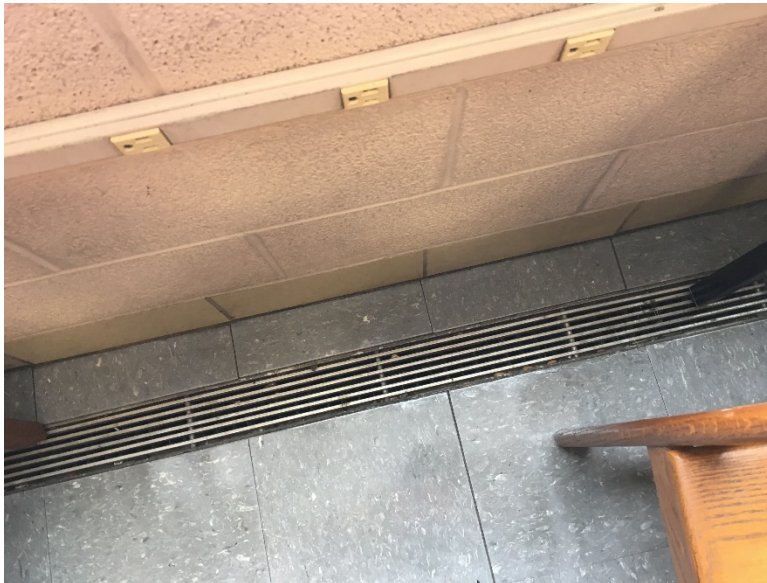
**Photograph 2:** Typical plenum vent, Room A6

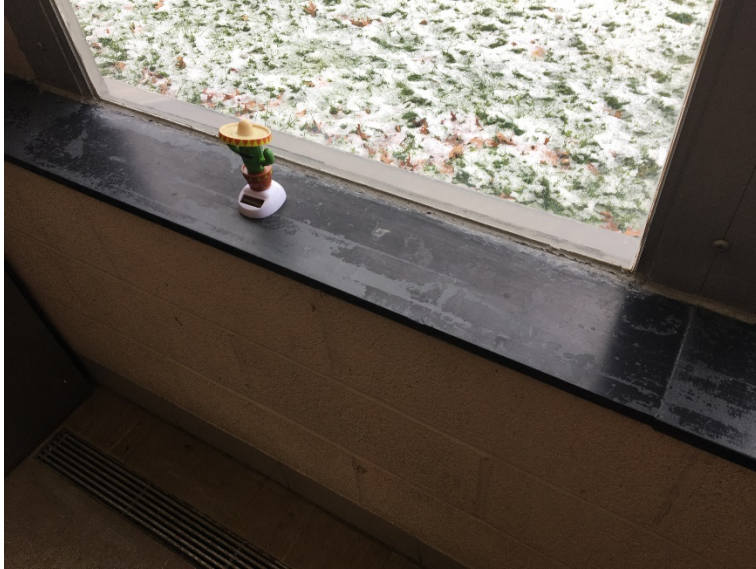
**Photograph 3:** Torn caulk, room B9

Based on our discussions and observations, it is our conclusion that the implementation of the BMPs at Burncoat is very effective. The vents to the HVAC plenum that serves most of the building were free of significant dust and debris. The observed windowsills and blinds exhibited little dust. The storage of educational materials on windowsills and air vents, which was observed in previous visits, has been remedied. The interior caulking on several windows (rooms B1, B9, D4, D8 and D14, which was intact at the time of our September 2018 observations, appears to have been torn, which can be addressed through routine touch-up patching.

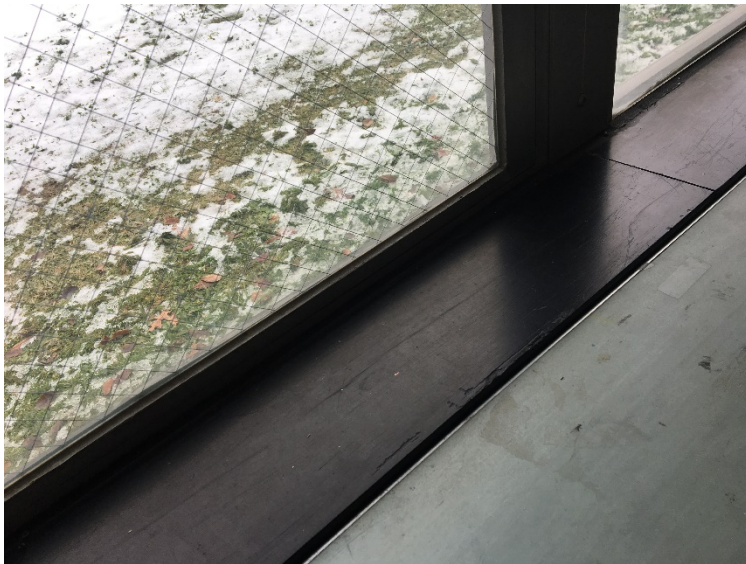
**Photograph 4:** Windowsill in band room

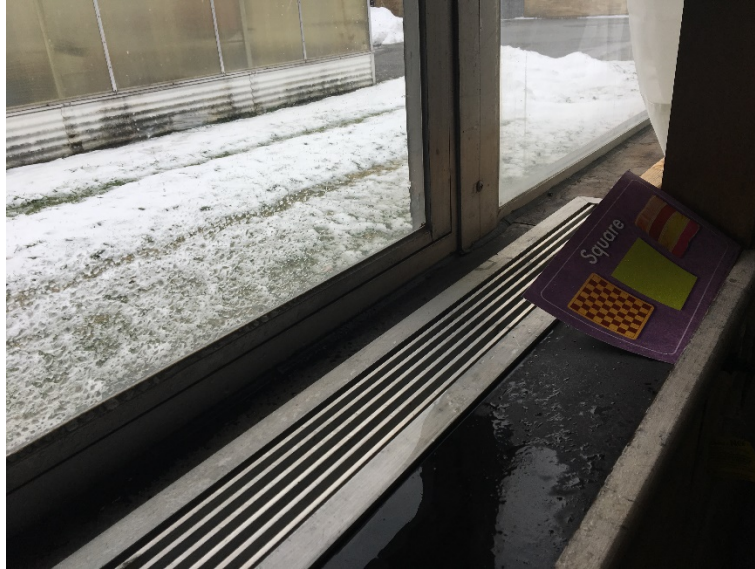
**Photograph 5:** Windowsill in room E8

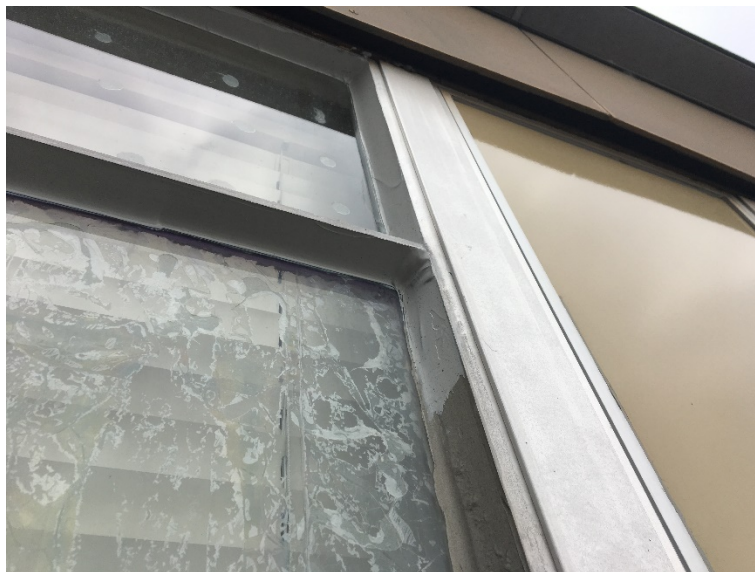
**Photograph 6:** Section of caulk on exterior window, showing original 2012 overcaulking (dark gray) and 2018 supplemental overcaulking (light gray)

Also in 2012, WPS encapsulated the suspect PCB containing caulk around all of the windows at Burncoat with an additional thick layer of non-PCB caulk. Exterior suspect caulking was likewise covered with new caulk to a height of eight feet above grade. No significant deterioration of the uncovered exterior caulking at the tops of window units was observed. This over-caulking is repaired on an as-needed basis to maintain its condition.
