March 19, 2019
File No. 5171-06-01

RE: February 2019 - PCB BMP Quarterly Status Report
Burncoat High School

Table 1 - Summary of BMP Observations
 Burncoat High School
 179 Burncoat Street
 Worcester, MA 01606
 February 22, 2019

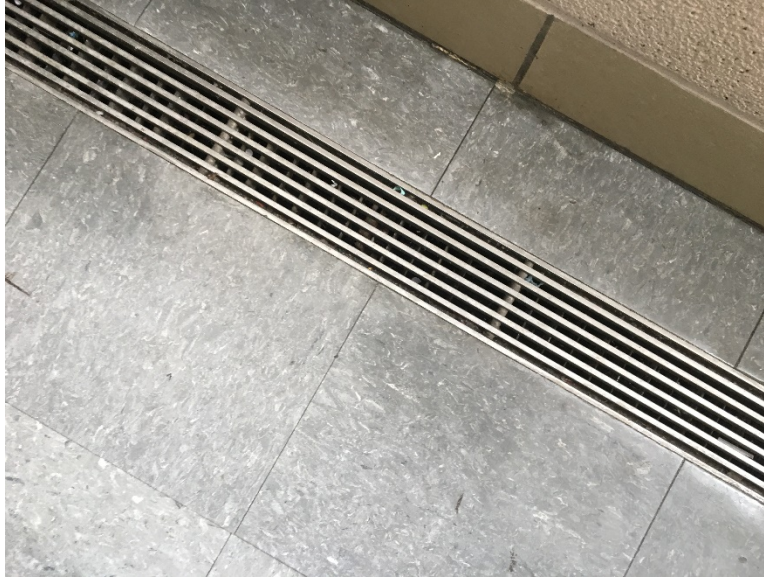
Photograph 1: Typical floor vent, Room A18

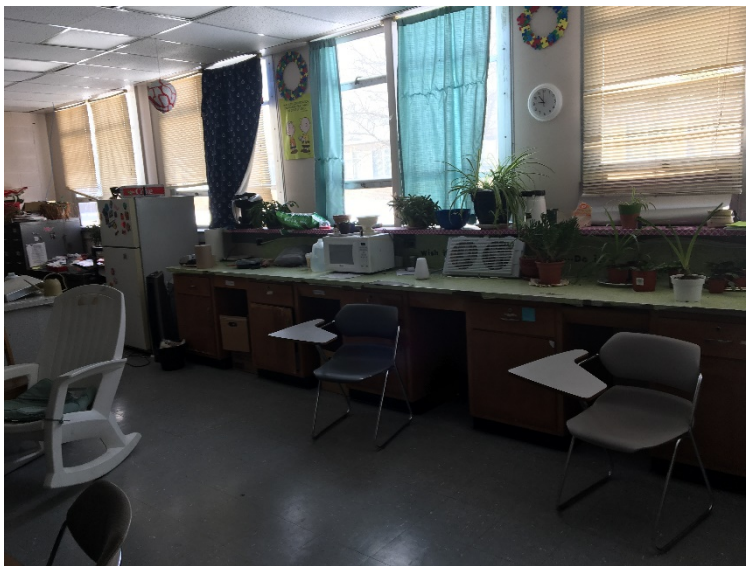
Photograph 4: Obstructed windowsill, Room E6
