March 19, 2019
File No. 5171-06-01

RE: February 2019 - PCB BMP Quarterly Status Report
Doherty Memorial High School

Table 1 - Summary of BMP Observations
Doherty Memorial High School
299 Highland Street
Worcester, MA 01602
February 22, 2019

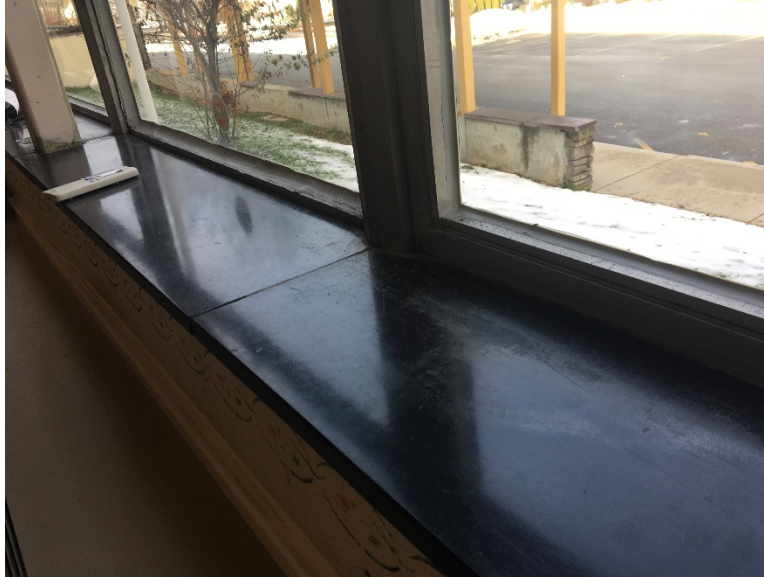
Photograph 1: Typical windowsill, front office

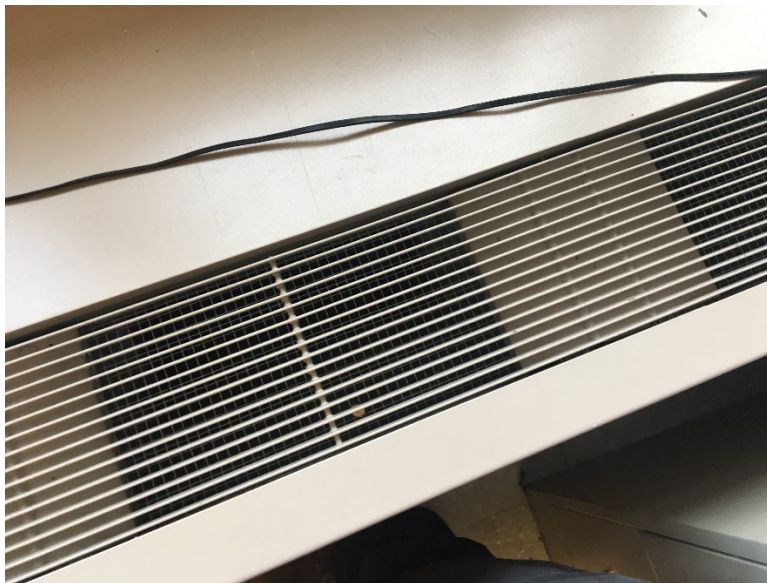
Photograph 2: Typical Univent, room 106

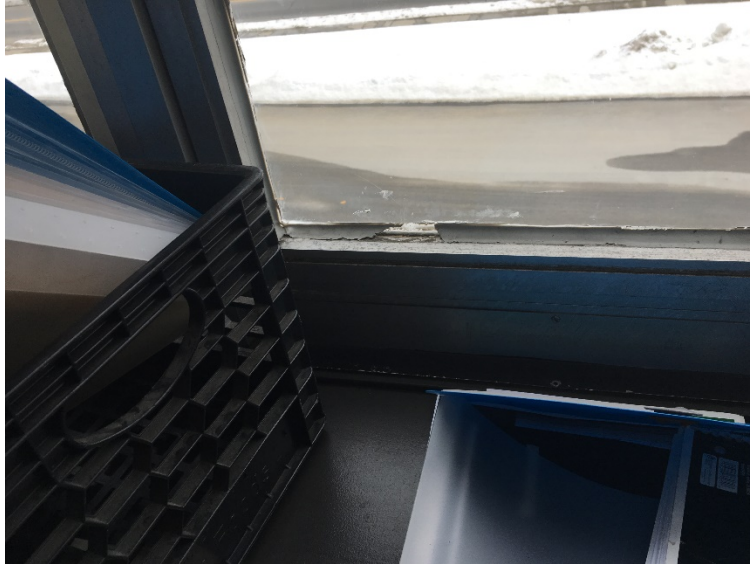
Also in 2012, WPS encapsulated the suspect PCB containing caulk around the windows at Doherty with an additional thick layer of non-PCB caulk. We observed this over-caulking in each room we visited and found that it was intact and in good condition. This over-caulking is repaired on an as-needed basis to maintain its condition.

Photograph 3: Minor damage to caulk, room 209

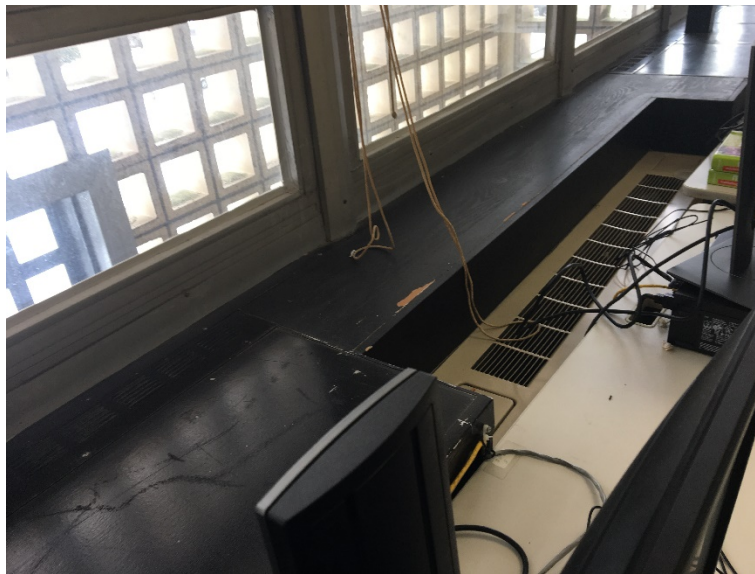
Photograph 4: Windowsill and univent, Room 207

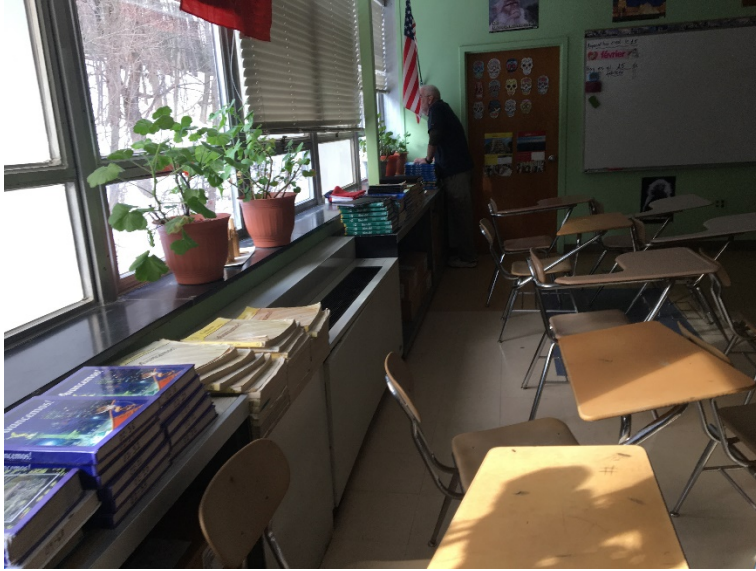
Photograph 5: Interior of Room 421

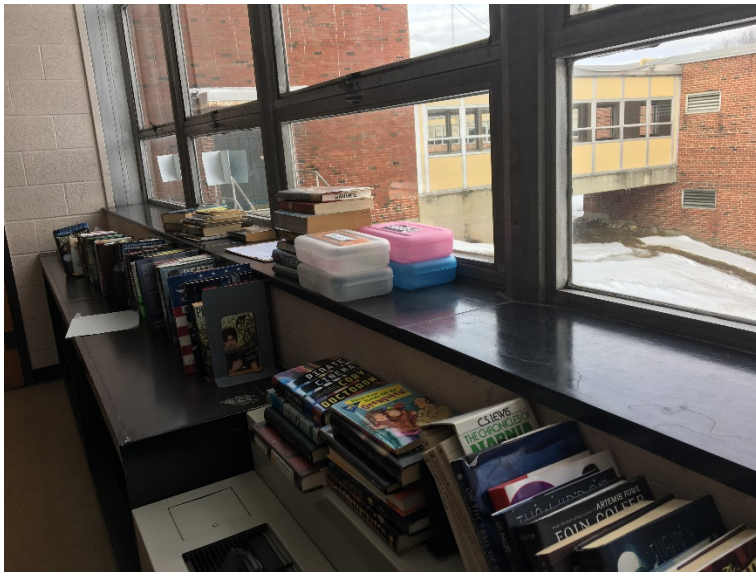
Photograph 6: Typical classroom, north face of 400s wing.
