June 12, 2019
File No. 5174-01-06

RE: May 2019 - PCB BMP Quarterly Status Report
Burncoat High School

Table 1 - Summary of BMP Observations
 Burncoat High School
 179 Burncoat Street
 Worcester, MA 01606
 May 22, 2019

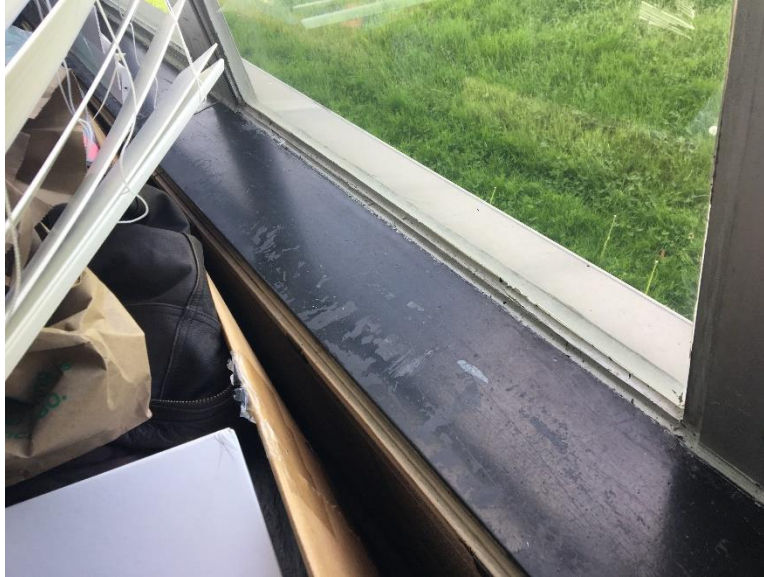
Photograph 1: Typical windowsill, Room A5

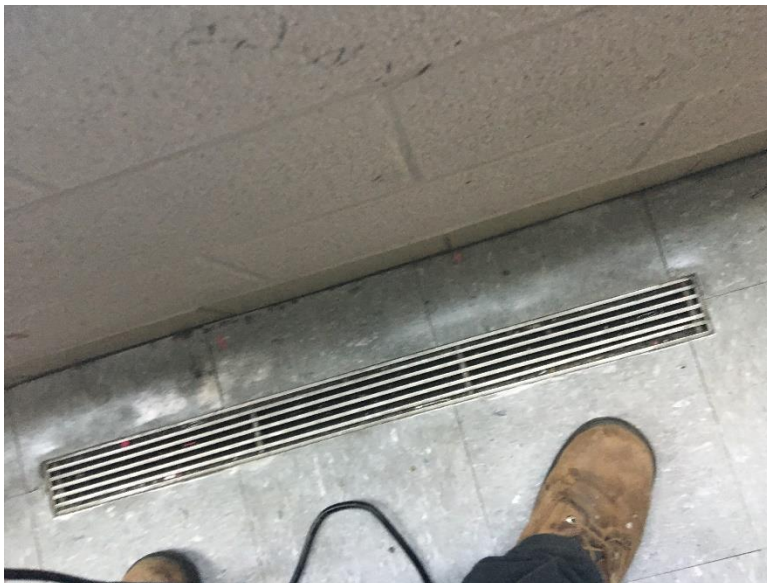
Photograph 2: Typical plenum vent, Room A5

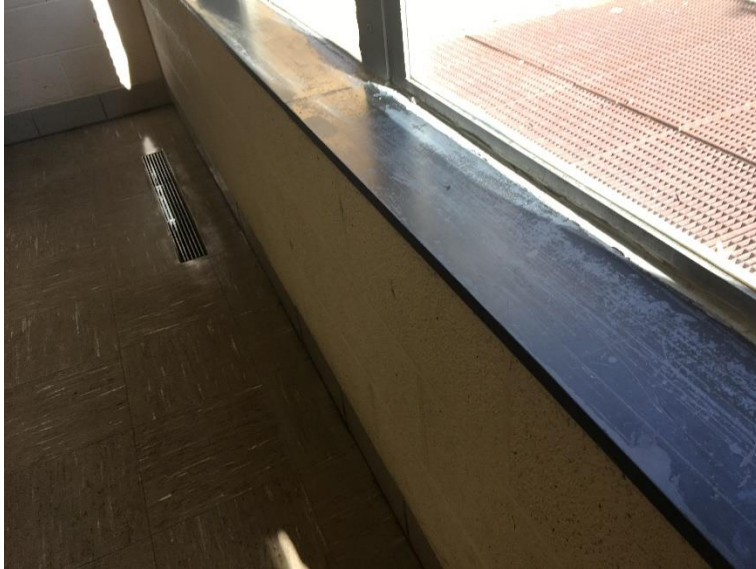
Photograph 3: Typical overcaulking, Room A16

Also in 2012, WPS encapsulated the suspect PCB containing caulk around all of the windows and doors at Burncoat with an additional thick layer of non-PCB caulk. Exterior suspect caulking was likewise covered with new caulk to a height of eight feet above grade. WPS subsequently over-caulked the remainder of the building's exterior door, window, and expansion joints in September and October 2018. This over-caulking is repaired as-needed to maintain its condition.

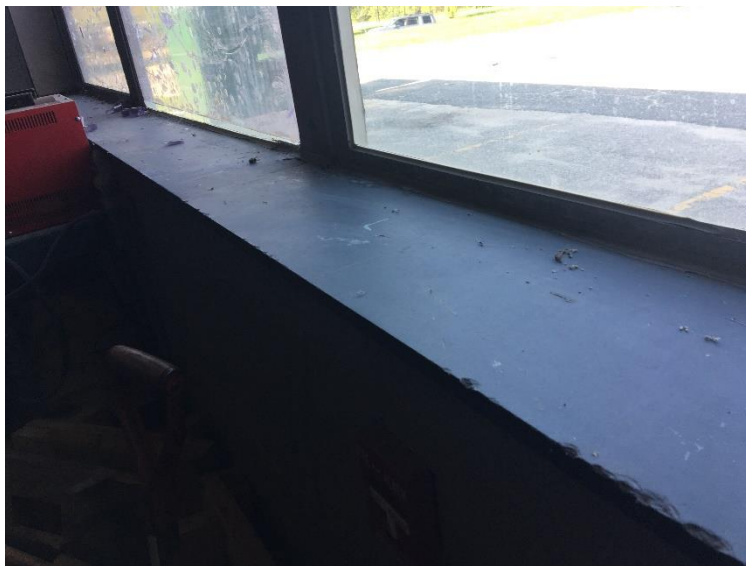
Based on our discussions and observations, it is our conclusion that the implementation of the BMPs at Burncoat is very effective. The vents to the HVAC plenum that serves most of the building were free of dust and debris. The observed windowsills and blinds exhibited little dust. The storage of educational materials on windowsills and air vents, which was observed in previous visits, has been reduced. OTO also obtained access to the auto shop space used by Quinsigamond Community College. Burncoat facilities staff indicated the City of Worcester is not responsible for maintenance or cleaning of this area. Significant dust was observed on windowsills in this space.

Photograph 4: Accumulated dust in QCC auto shop area

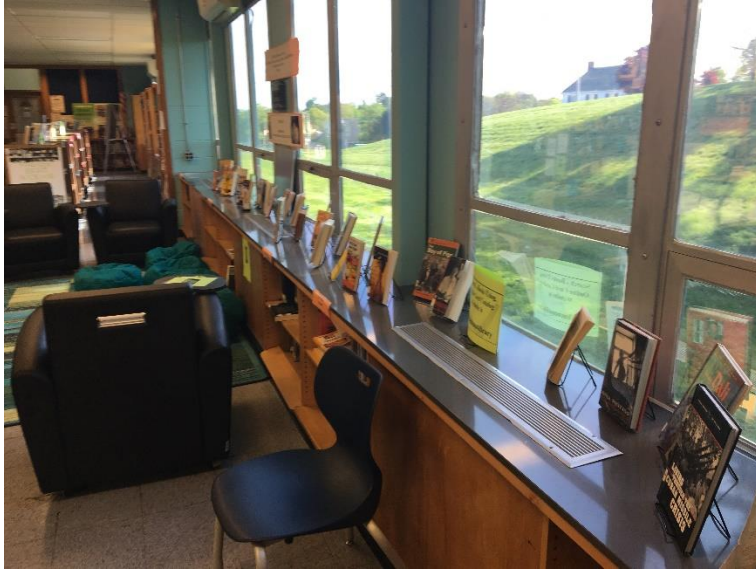
Photograph 5: Windowsill in Library
