June 12, 2019
File No. 5174-01-06

RE: May 2019 - PCB BMP Quarterly Status Report
Doherty Memorial High School

Table 1 - Summary of BMP Observations
Doherty Memorial High School
299 Highland Street
Worcester, MA 01602
May 22, 2019

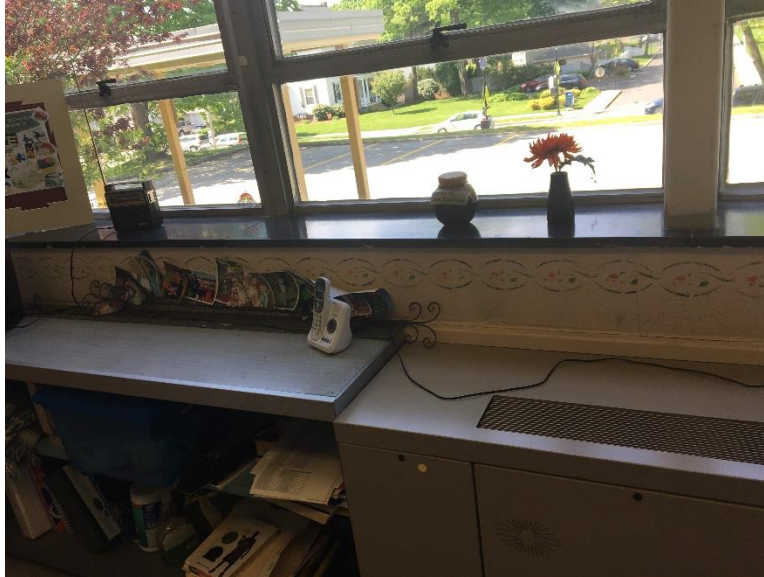
Photograph 1: Typical windowsill, guidance area

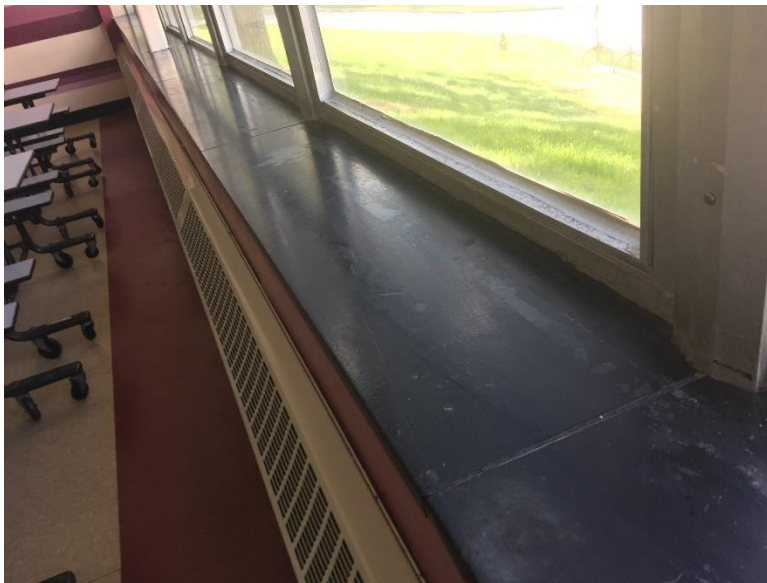
Photograph 2: Typical windowsill, cafeteria

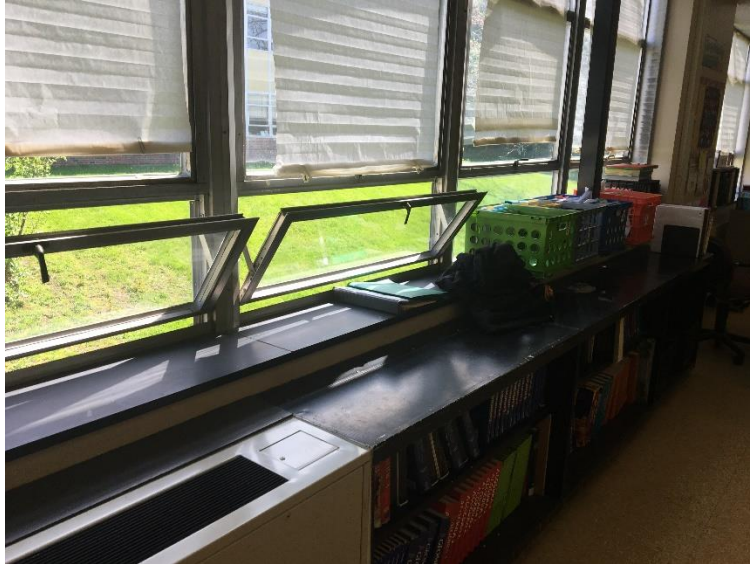
Photograph 3: Windowsill in Room 211

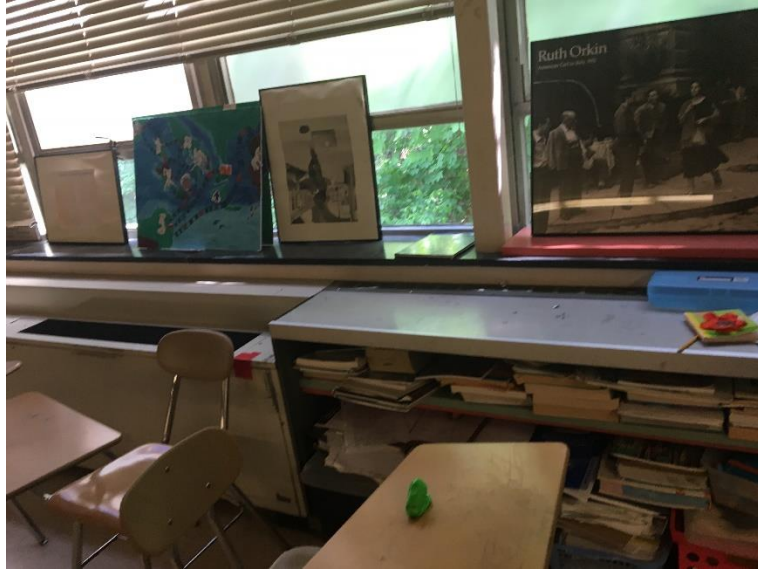
Photograph 5: Interior of Room 425

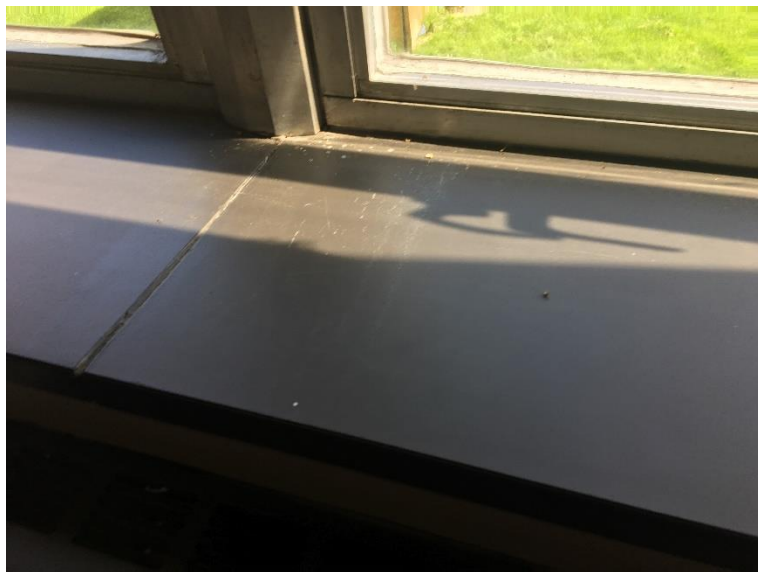
Photograph 6: Visible pollen accumulation, Room 419
