During the 2018-19 school year, the Administration has worked to identify the sources of complaints of mold at Columbus Park Preparatory School.

INDOOR AIR QUALITY ASSESSMENT

**Columbus Park School
75 Lovell Street
Worcester MA**

Prepared by:
Massachusetts Department of Public Health
Bureau of Environmental Health
Indoor Air Quality Program
November 2019

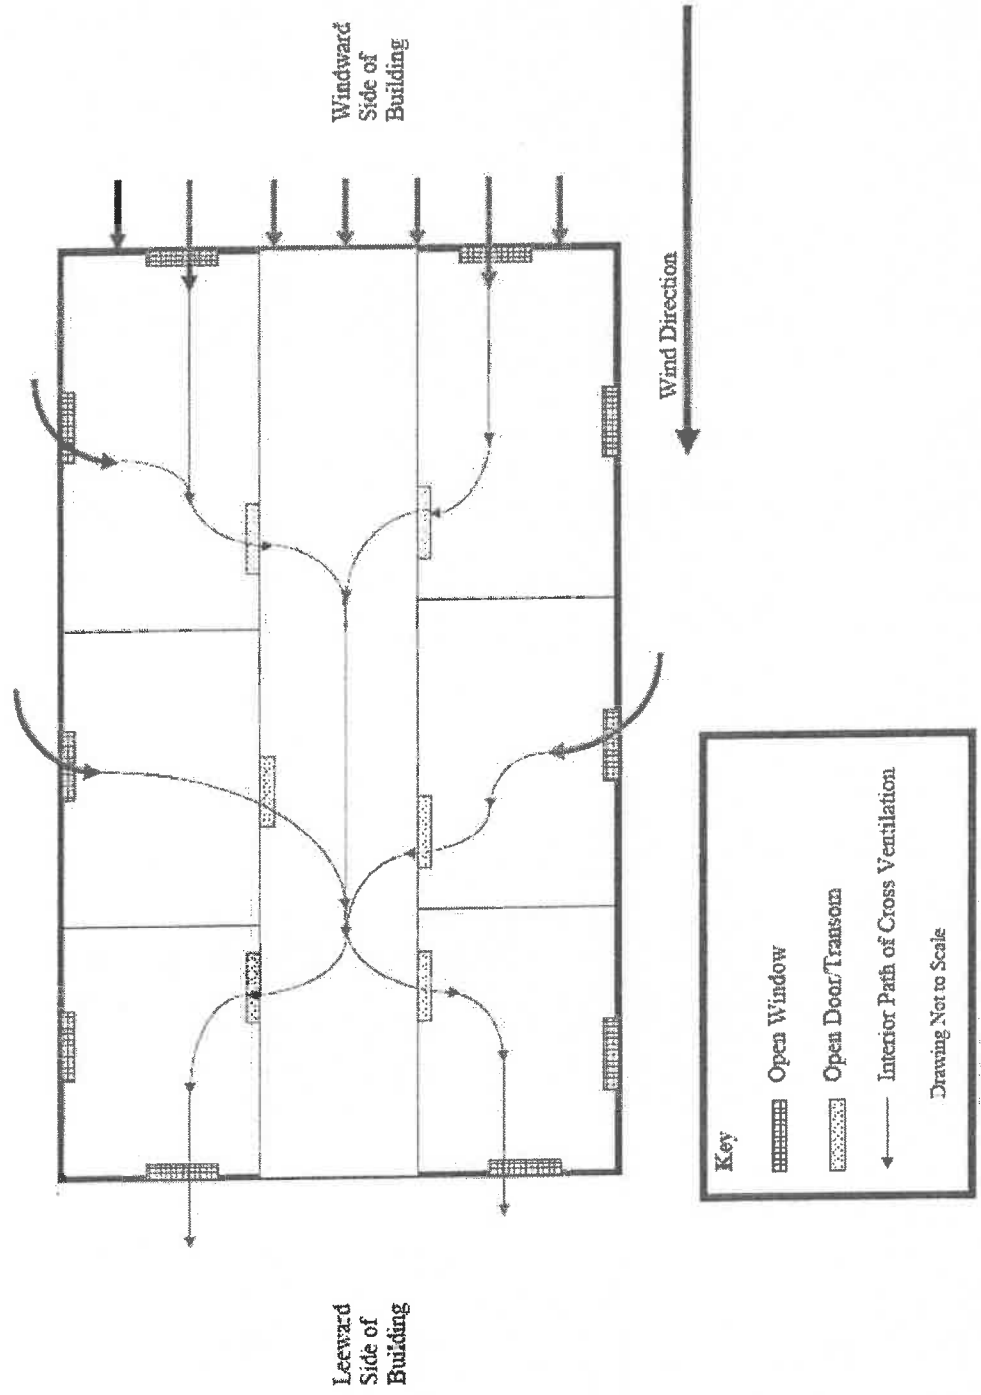
Figure 1
Cross Ventilation in a Building Using Open Windows and Doors/Transoms

The 1913 portion of the building appears to be originally designed to provide fresh air by opening windows and using cross-ventilation. The building is equipped with windows on opposing exterior walls along with hinged windows (called transoms, Picture 4) located above the doors between classrooms and the hallways. The transom enables the classroom doors to be closed while maintaining a pathway for airflow. This design allows for airflow to enter an open window, pass through a classroom, pass through the open transom, enter the hallway, pass through the opposing open classroom transom, into the opposing classroom and exit the building

on the leeward side (opposite the windward side) (Figure 1). With all windows and transoms open, airflow can be maintained in a building regardless of the direction of the wind. The system fails if the windows or transoms are closed (Figure 2). All transoms in the building were sealed, which prevents cross-ventilation as originally designed. The 1950s building has no transoms.

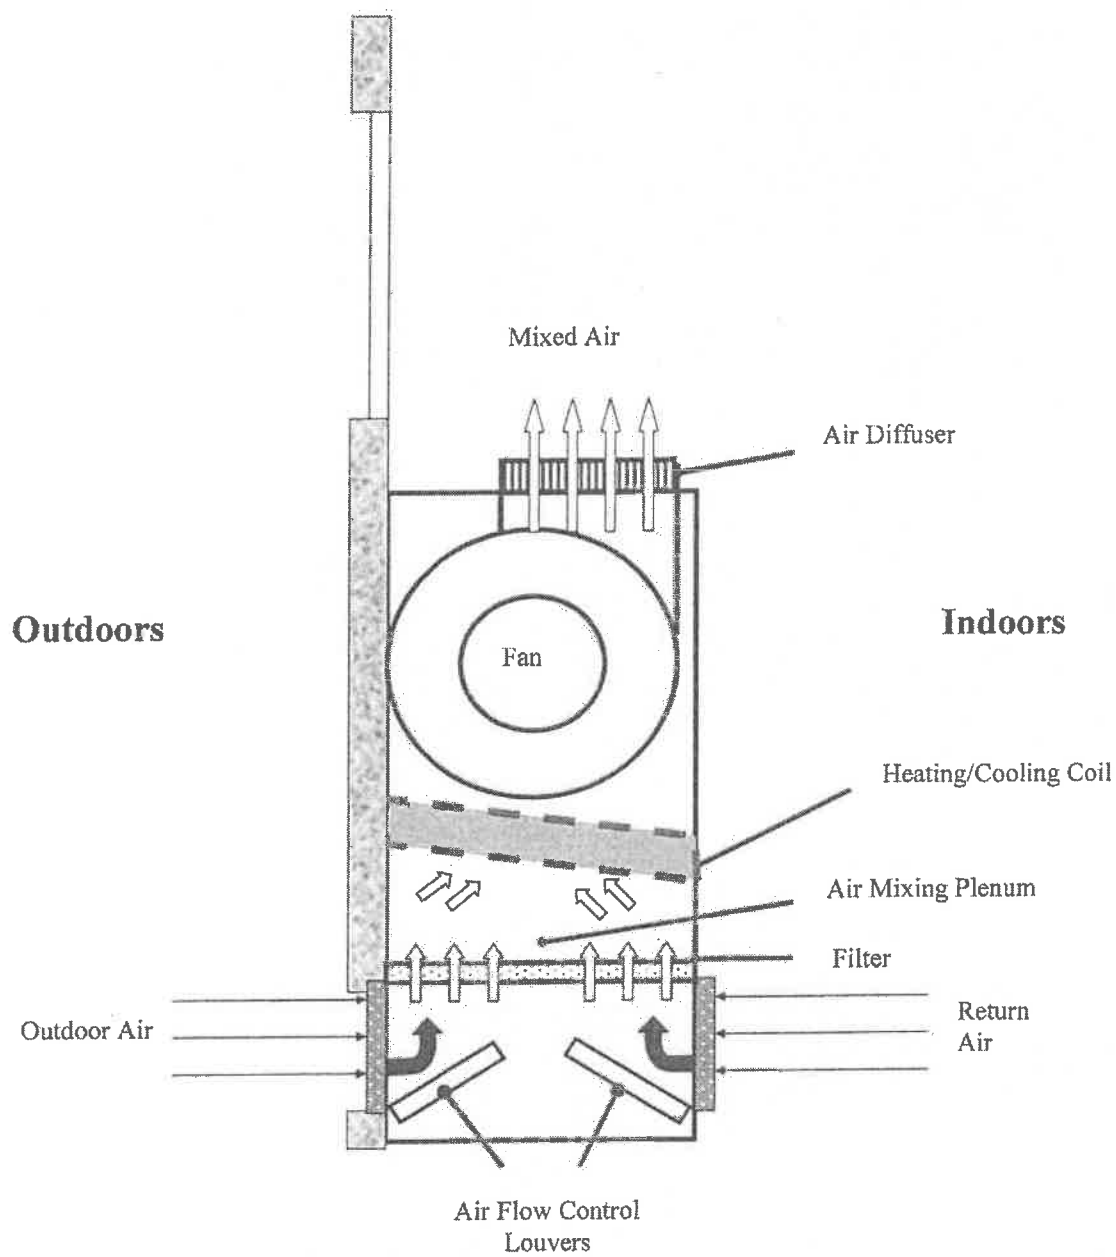
Figure 3: Unit Ventilator (Univent)

Fresh air for classrooms in the 1950s wing is supplied by a unit ventilator (univent) system (Picture 5). Univents draw air from outdoors through a fresh air intake located on the exterior walls of the building and return air through an intake located at the base of each unit. Fresh and return air are mixed, filtered, heated and provided to classrooms through an air diffuser located in the top of the unit (Figure 3).

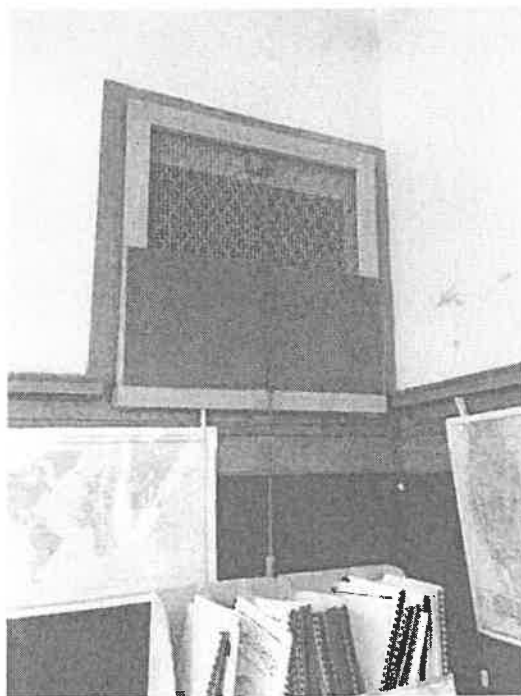
Picture 1

Fresh air supply vent

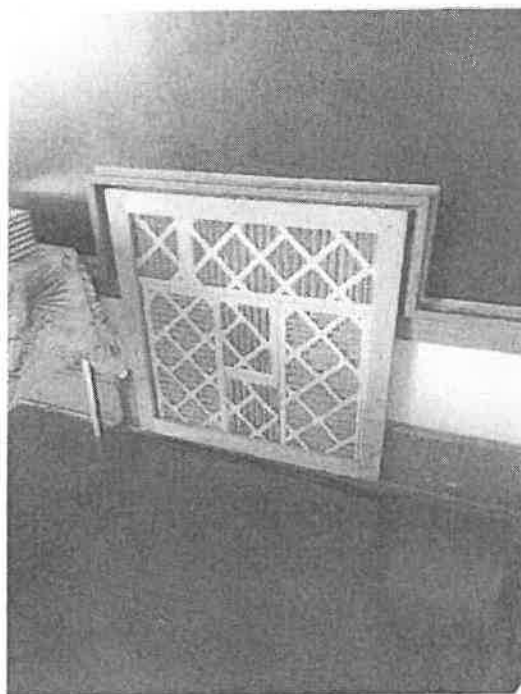
Picture 2

Return air vent with filters attached

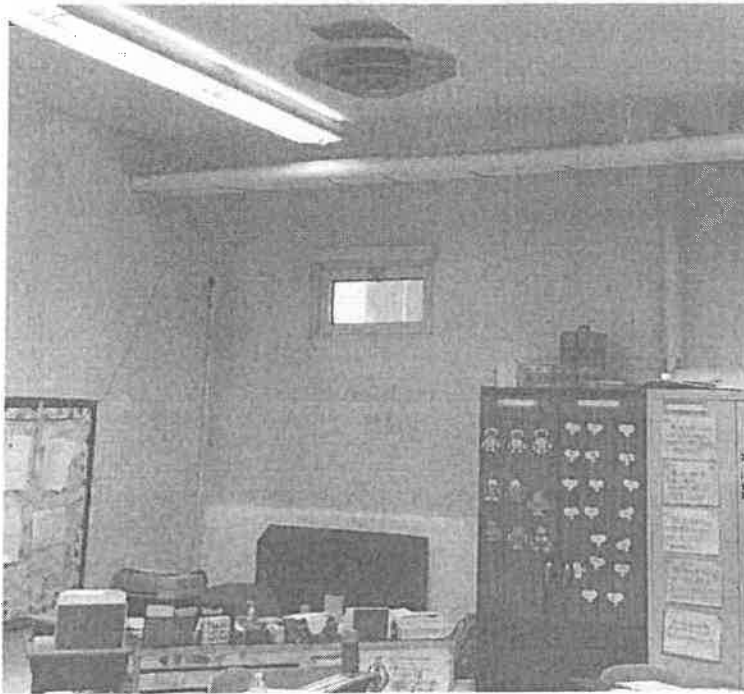
Picture 3

The building has two types of ventilation systems. The 1913 wing was originally equipped with a natural ventilation system that used the stack effect to circulate heat and air through classrooms. It appears that the original airshafts were converted into a mechanical ventilation system with an air handling unit (AHU) located in the basement. Classrooms in the 1913 wing have vents that now function as mechanical supply and return vents (Pictures 1 and 2). The basement has been subdivided into classrooms; added ductwork supplies fresh air through diffusers (Picture 3).

Retrofitted basement fresh air supply and ductwork

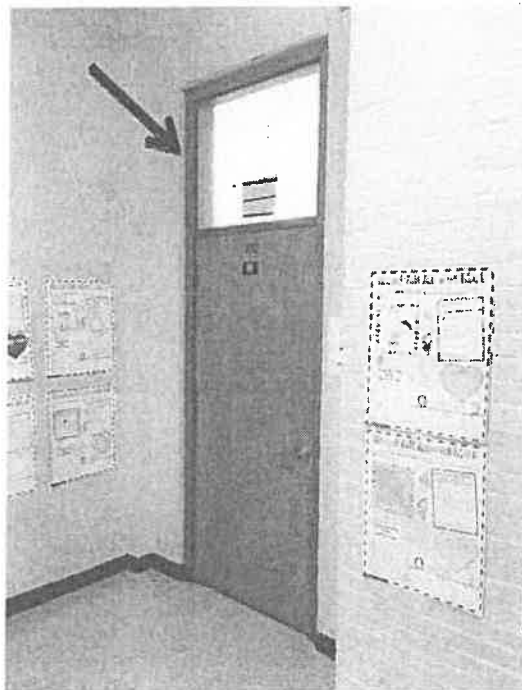
Picture 4

Transom

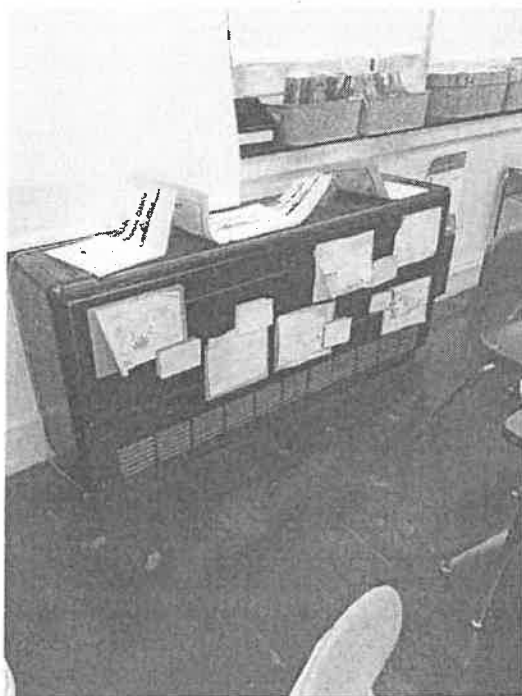
Picture 5

With regard to HVAC system function, according to the American Society of Heating, Refrigeration and Air-Conditioning Engineers (ASHRAE), the service life for a unit heater, hot water or steam is 20 years, assuming routine maintenance of the equipment (ASHRAE, 1991). Despite attempts to maintain the univents (e.g., oiling bearings, changing filters regularly), the operational lifespan of this equipment has been exceeded in all areas of the CPS. Maintaining the balance of fresh to exhaust air will become more difficult as the equipment ages and as replacement parts become increasingly difficult to obtain.

Unit ventilator (univent)

1. Consideration should be given to replace HVAC units/components as they become past their service life. If not conducted already, consider contacting an HVAC engineering firm for an assessment of the ventilation system’s components and control systems (e.g., controls, air intake louvers, thermostats). Based on the age, physical deterioration, and availability of parts for ventilation components, such an evaluation is necessary to determine the operability and feasibility of repairing/replacing the equipment.

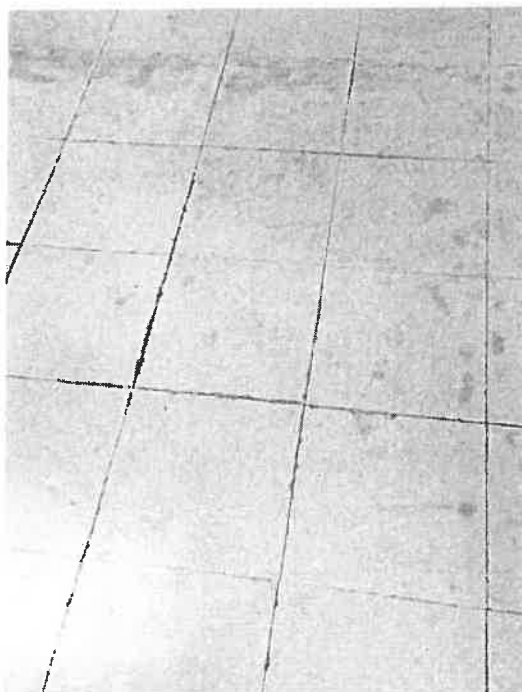
Picture 6

As mentioned previously, the lowest floor of the building was converted into classrooms sometime in the 1950s-1960s. The basement has several flooring materials, including terrazzo and tile. Due to the condition of hallway floor tiles (Picture 6), it appears that the basement floor becomes wet with condensation during hot, humid weather, despite the use of dehumidifiers in basement classrooms. This phenomenon was likely exacerbated during the weather conditions experienced in New England during the summer of 2018:

Since the building was originally constructed in 1913, it is highly unlikely that the floor has either insulation or a vapor barrier. In this condition, the floor likely has a temperature similar the material beneath the floor (e.g. soil, sand, rock ledge, rock fill). If the temperature of the floor is below or equal to the dew point, the floor will begin to accumulate condensation¹.

Water-damaged floor tiles in basement

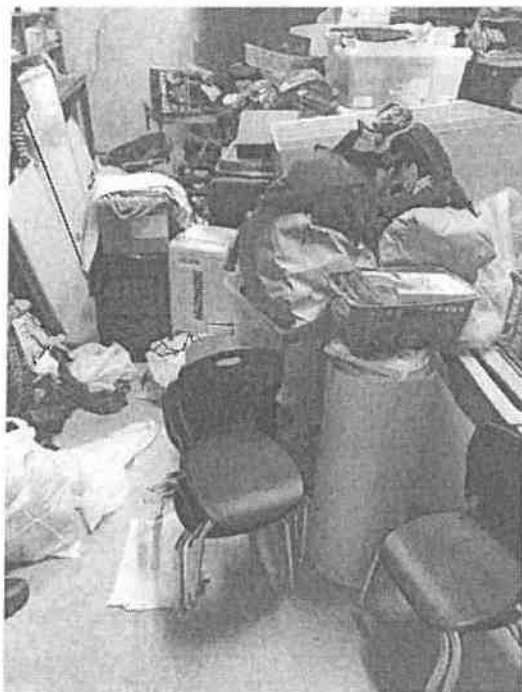
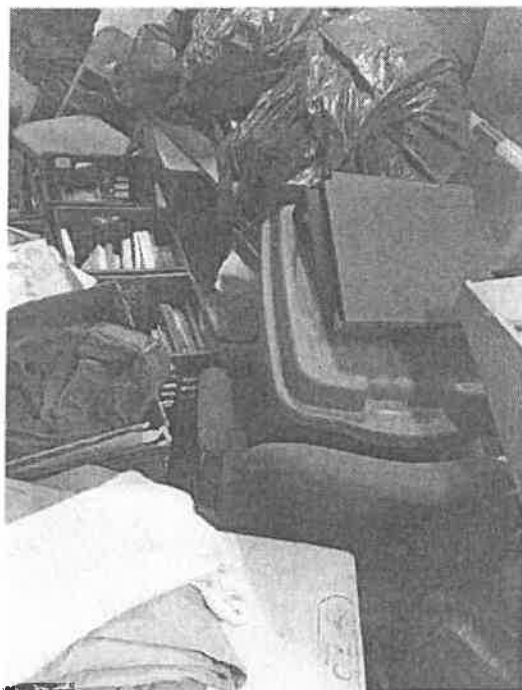
The basement level of the building contains a significant amount of materials that can support mold growth if exposed to moisture (Pictures 7 and 8). In addition, a number of conditions exist that may increase relative humidity/moisture conditions in the basement:

- Porous materials were present in the basement area. It is highly recommended that materials that can support mold growth be removed. Porous materials such as paper, cardboard, cloth and leather can all become mold colonized if repeatedly exposed to moisture.

Stored materials in basement

4. Remove all porous materials from the basement floor including carpeting and stored materials. Reduce the amount of materials stored in the basement area in general, and store remaining materials in waterproof totes.

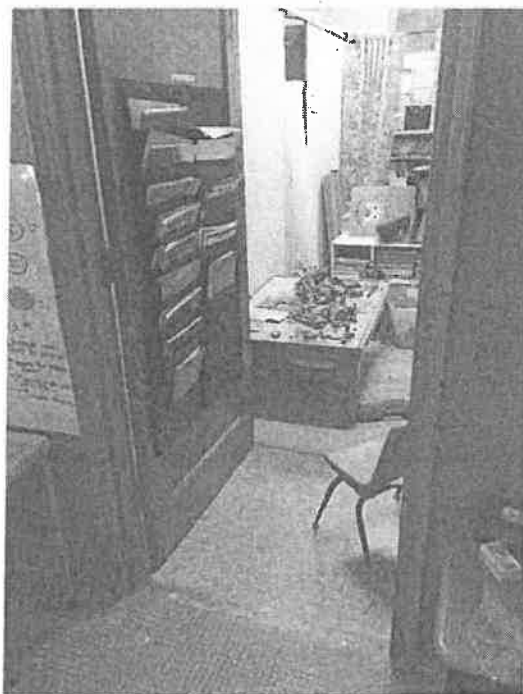
Picture 9

- The basement used to contain locker rooms including a shower (Picture 9). It could not be determined if the shower floor drains were permanently sealed. Drains are usually equipped with curved pipe in an “s” shape to form a device called a trap. Drain traps are normally filled with water to create a seal between the building's sanitary sewer line and the system designed to ventilate sewer gas. Without the water seal in a drain trap, water vapor and sewer gas can be drawn into an area. Sewer water can contain a number of bioaerosols (including fungi such as mold) that can be drawn into an area with a dry drain trap, particularly when a sewer system has a large influx of water during heavy rainstorms. The water inside the trap requires replenishment on a regular basis (every other day, particularly during the heating season) to maintain airtightness of the trap.

Former locker room shower area

5. Ensure all former locker room drains are permanently sealed.
6. Operate dehumidifiers during hot, humid weather to reduce relative humidity in basement areas. Ensure all dehumidifiers are emptied, cleaned and maintained regularly to prevent spills and odors.
