Worcester Public Schools

Ventilation Assessment & COVID-19 Mitigation Strategies

City View Elementary School Worcester, MA

January 31, 2021

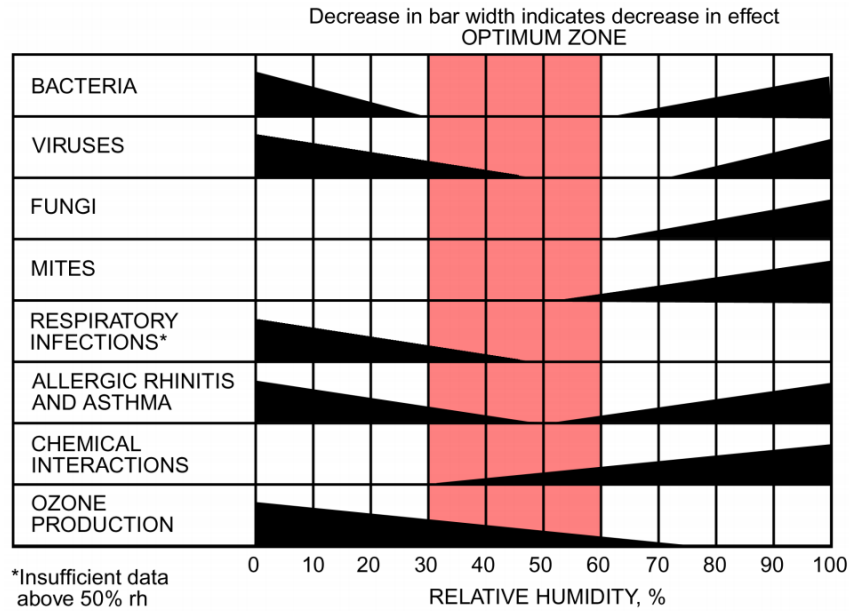
Measurements taken included space humidity. Humidity levels has been found to play a role in the controlling the spread of COVID-19. ASHRAE recommends winter humidity levels be kept between 40% to 50% and summer humidity levels between 50% and 60% with a summer target of 50%. Maintaining humidity levels within the above ranges has been found to limit the growth and transmission of certain bacteria and viruses as well as supports respiratory function. The below chart is taken from the 2020 ASHRAE Handbook – HVAC Systems and Equipment and reflects the impact of space humidity on the increase or decrease of effect on various space contaminants. This chart only reflects increase or decrease of effect from humidity and does not intend to imply that there is zero growth or impact of a certain contaminant when the sloped bar graph zero's out.

Fig. 1 Optimum Humidity Range for Human Comfort and Health
 (Adapted from Sterling et al. 1985)

The City View Elementary School HVAC systems have no active humidity control. Space dehumidification is limited only to those areas which have air conditioning cooling. However, this dehumidification is not actively controlled by a humidity setpoint. Moisture removal only occurs when these systems are operating in the cooling mode. As such, space humidity may climb above 60% during periods when low thermal loads require less cooling (i.e., a cool damp day) or swing above and below 60% as the systems cycle based on space temperature.

Caution must be taken when considering adding active humidification to existing buildings as it is imperative that the buildings thermal envelope and vapor barriers be reviewed. Although moderately aged structures, such as City View Elementary School often have a fair vapor barrier the varying wall and window construction and thermal characteristics may limit the ability for active humidification. Adding humidity in the wintertime without consideration of the building construction could result in moisture condensation on windows and within wall assemblies which may create a damaging and unhealthy condition for the building and its occupants. Review of the building envelope should take place prior to consideration of the addition of any humidification system. As such, our recommendations contained with this report exclude active humidification control until such time as the envelope can be reviewed.
