# **Worcester Public Schools**

## **Ventilation Assessment & COVID-19 Mitigation Strategies**

### **Taylor Building Worcester, MA**

**January 31, 2021**

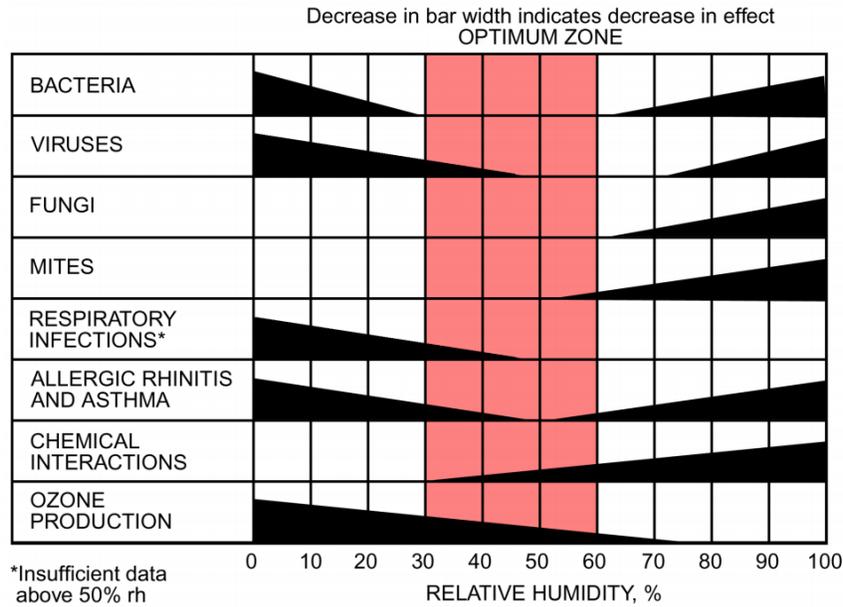
**Fig. 1 Optimum Humidity Range for Human Comfort and Health**  
(Adapted from Sterling et al. 1985)

Measurements taken included space humidity. Humidity levels has been found to play a role in the controlling the spread of COVID-19. ASHRAE recommends winter humidity levels be kept between 40% to 50% and summer humidity levels between 50% and 60% with a summer target of 50%. Maintaining humidity levels within the above ranges has been found to limit the growth and transmission of certain bacteria and viruses as well as supports respiratory function. The below chart is taken from the 2020 ASHRAE Handbook – HVAC Systems and Equipment and reflects the impact of space humidity on the increase or decrease of effect on various space contaminants. This chart only reflects increase or decrease of effect from humidity and does not intend to imply that there is zero growth or impact of a certain contaminant when the sloped bar graph zero's out.

The Taylor Building HVAC systems have no active humidity control. Space dehumidification is limited only to those areas which have air conditioning cooling. However, this dehumidification is not actively controlled by a humidity setpoint. Moisture removal only occurs when these systems are operating in the cooling mode. As such, space humidity may climb above 60% during periods when low thermal loads require less cooling (i.e., a cool damp day) or swing above and below 60% as the systems cycle based on space temperature.

Caution must be taken when considering adding active humidification to existing buildings as it is imperative that the buildings thermal envelope and vapor barriers be reviewed. Older structures, such as Taylor Building often have poor vapor barrier the varying wall and window construction and thermal characteristics may limit the ability for active humidification. Adding humidity in the wintertime without consideration of the building construction could result in moisture condensation on windows and within wall assemblies which may create a damaging and unhealthy condition for the building and its occupants. Review of the building envelope should take place prior to consideration of the addition of any humidification system. As such, our recommendations contained with this report exclude active humidification control until such time as the envelope can be reviewed.
